BOARD MEETING AGENDA
Monday, May 23, 2016
Regular Meeting - 7:00 P.M.

Union Sanitary District
Administration Building
5072 Benson Road
Union City, CA 94587

- Motion 10. Accept the Final Seismic Assessment Reports from Degenkolb Engineers *(to be reviewed by the Construction Committee)*.

Staff recommends the Board accept the final seismic assessment reports, dated April 22, 2016, from Degenkolb Engineers.

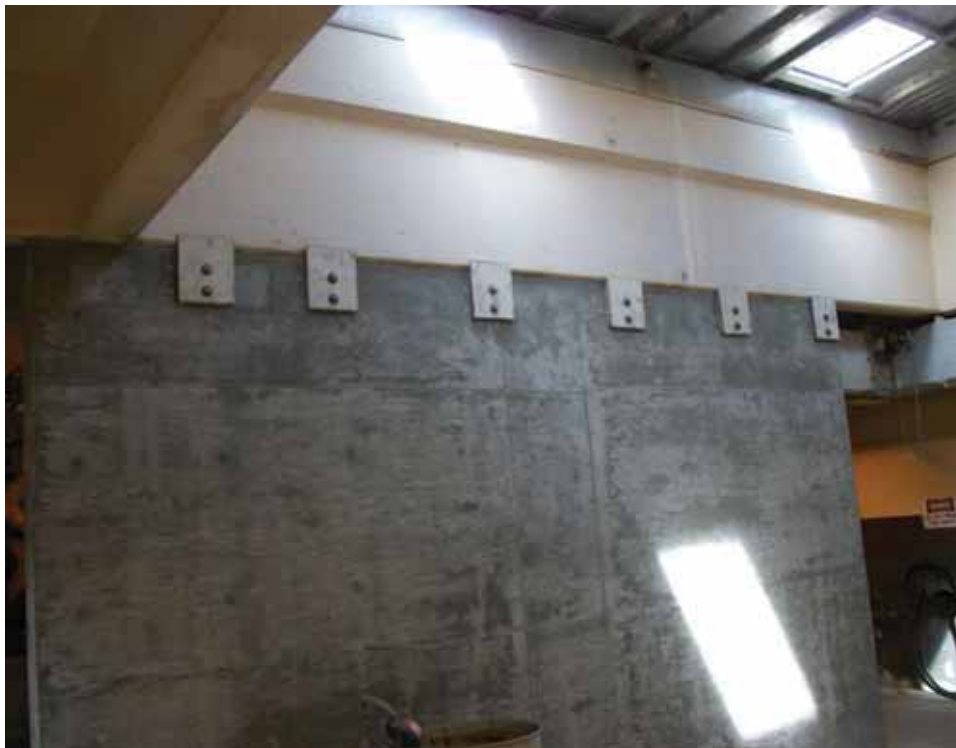
Figure 3: New Concrete Partition Wall in Degritter Building

New cast-in-place concrete walls at the second floor near the Degritter equipment are tied into the cast-in-place beam elements above (noted “diaphragms” in the drawings). These beam elements were originally designed and intended to take gravity loads associated with framing the large openings in the roof. Note that these “diaphragm” elements were designed by the contractor so it is not completely known how they are tied into the precast beam elements surrounding them. However, these beams are very likely deficient for lateral forces and eccentricity placed on them by the new concrete wall elements because the beam elements would have to resolve the eccentricity into the very thin diaphragm of the precast double-t beams. The new concrete walls and their attachment to the “diaphragm” beams are shown in Figure 3.

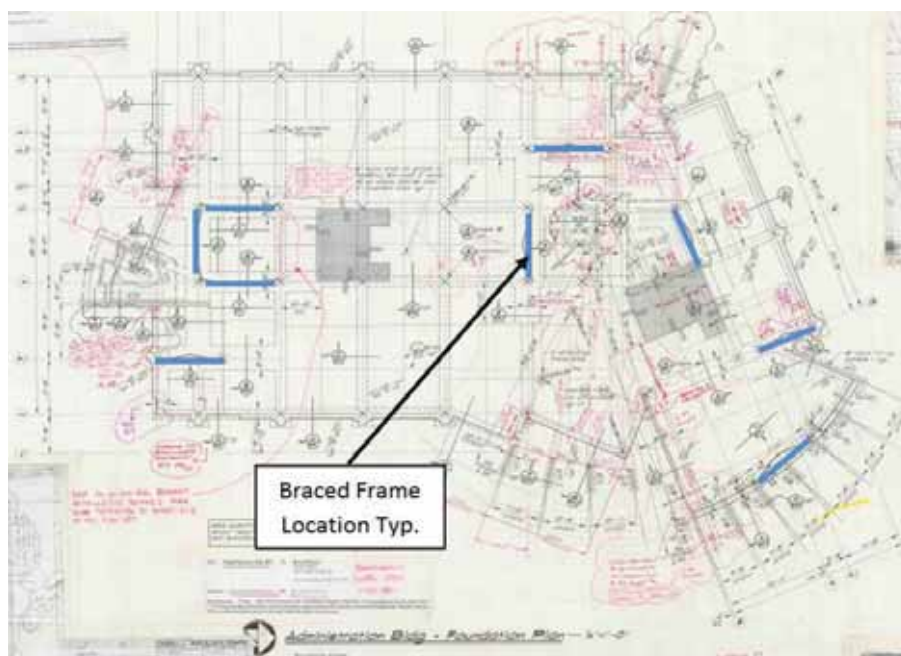
Figure 11: First-Story Braced-Frame Locations in Administration Building

In the Administration Building, the major seismic deficiencies are non-ductile braced frames and inadequately braced precast panels. The deficiencies can be mitigated by replacing the existing braces with new buckling restrained braces and bracing the precast panels.

Concentrically braced frames serve as the structure's primary lateral force resisting system. The brace locations on the first-story are shown in Figure 11. As noted in greater detail below, the concentrically braced frames do not have ductile detailing and are not expected to perform well in the DBE. Furthermore, the tall architectural precast concrete panels are not well tied into the structure and may collapse in the DBE. Given the Administration Building's poorly detailed systems and structural complexity, it is rife with potential seismic deficiencies as discussed in greater detail below.

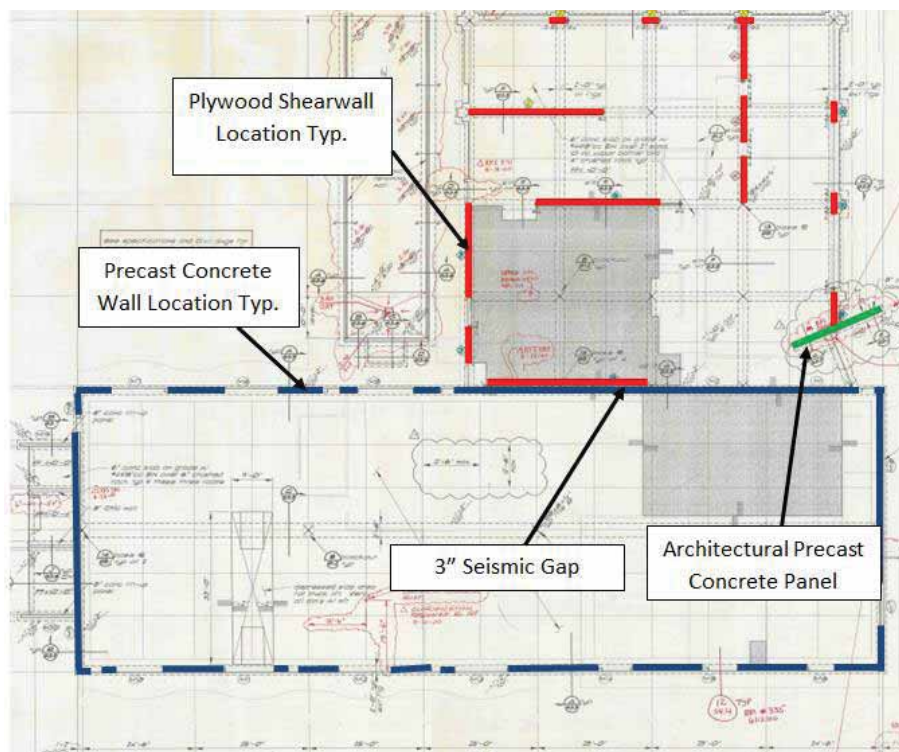
Figure 13: Wall Locations in Field Operations Building

The locations of the plywood shear walls and precast concrete tilt-up walls are shown in Figure 13. As noted in greater detail below, the main deficiency of the Field Operations Building is the deficient connections between the precast concrete walls and the plywood diaphragms. These limited connections are not expected to perform well in the DBE. Furthermore, the structural separation between the two structures appears to be inadequate which could lead to pounding between the two structures. These deficiencies are discussed in greater detail below

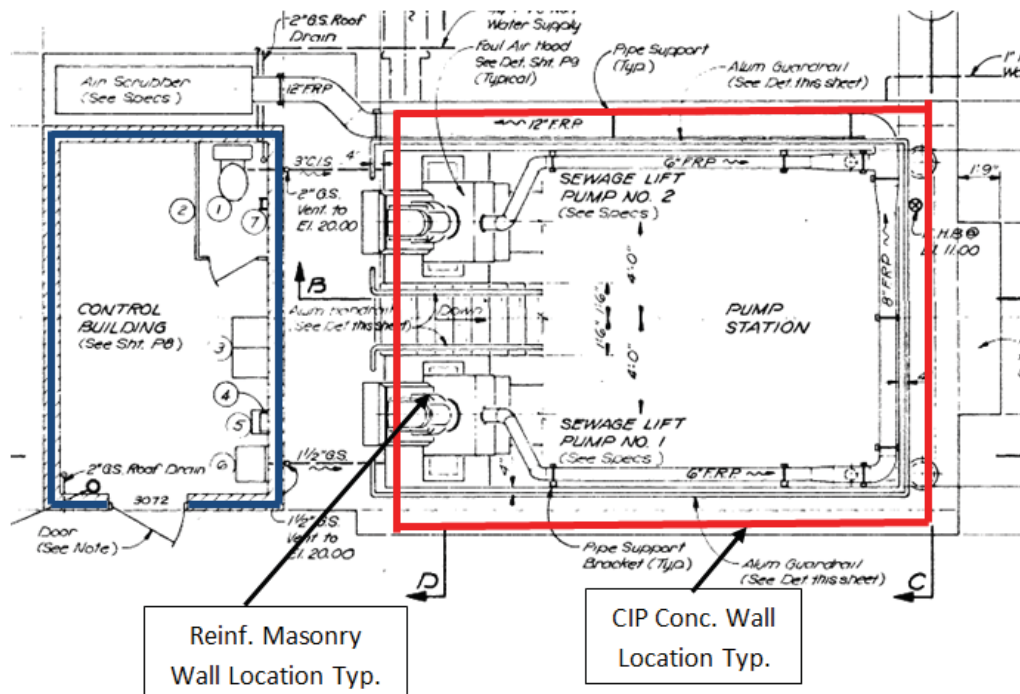
Figure 15: Paseo Padre Lift Station Wall Locations

The main lateral force resisting system of the Paseo Padre Lift Station is concrete walls below grade, and masonry walls above grade. The masonry walls above grade and concrete walls below grade are highlighted in Figure 15. The main deficiency with the lift station is the lack of out-of-plane anchorage of the masonry walls, which is discussed in greater detail below.

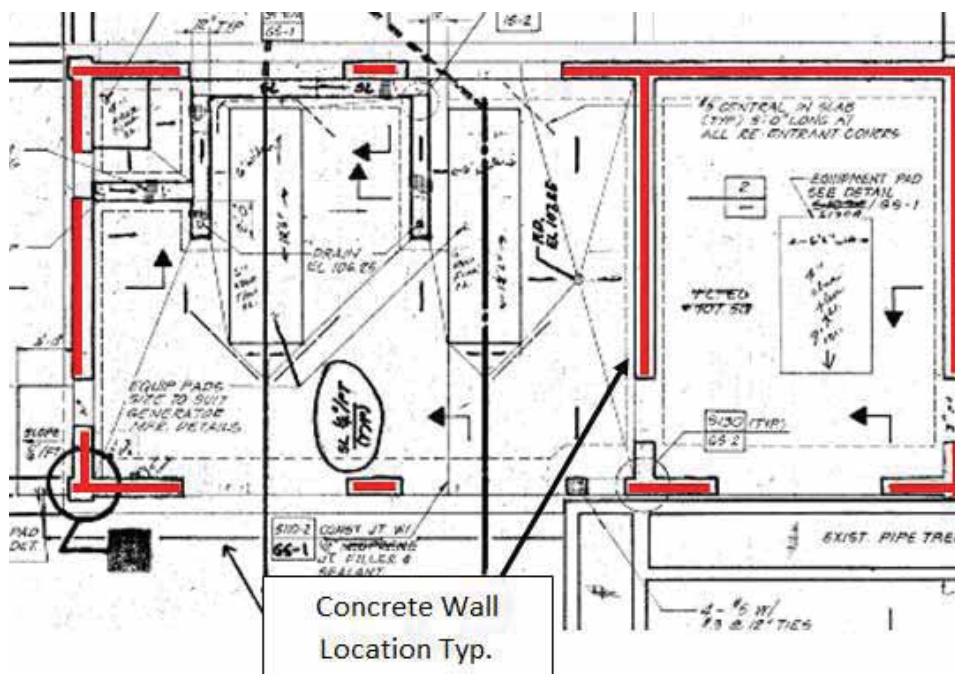
Figure 17: Generator Building #2 Wall Locations

The precast concrete roof is covered with a reinforced concrete topping slab which is tied down to the East and West concrete walls with dowels. The North and South concrete walls are tied to the roof beam stems with steel embed plates, and the center concrete wall is tied to the concrete roof beam stems with small steel angles. These concrete walls resist seismic induced forces and the wall locations are shown in Figure 17. Based on the preliminary screening, the main seismic deficiency of Generator Building #2 is related to overstressed connections between the diaphragm and the cast-in-place concrete walls, as discussed in further detail below.

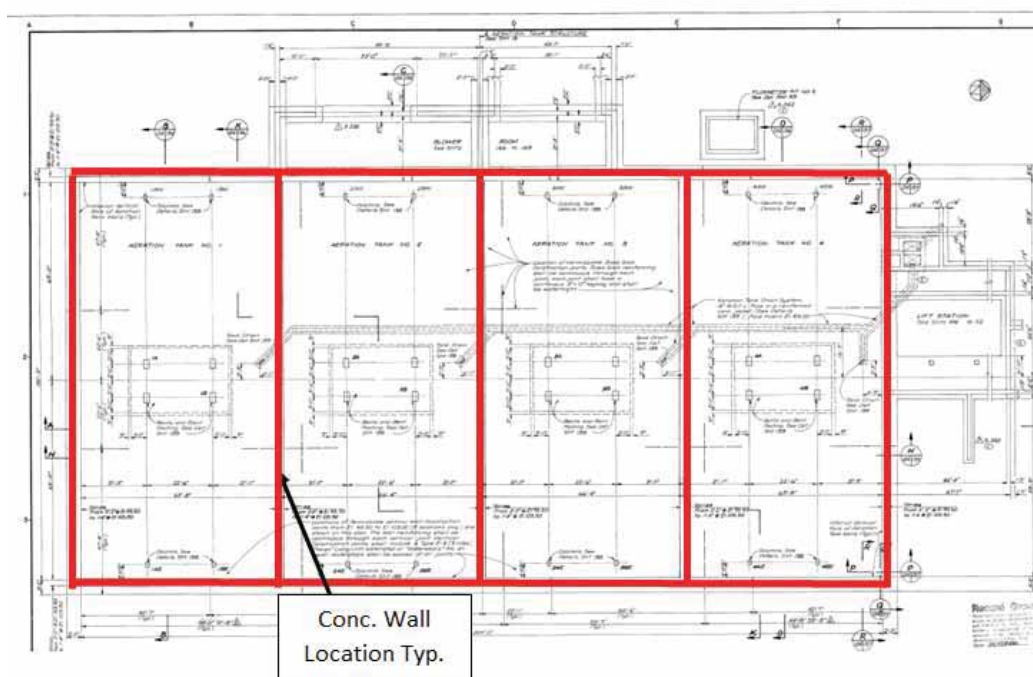
Figure 21: Aeration Basin Concrete Wall Locations

these seismic forces at a life-safety level. However, damage to the roof and its connections are expected. Furthermore, unlike at the perimeter of the basins, and at the distribution channels that run in the East-West direction, the center North-South running influent channel is not supported by a continuous wall. Rather, it is supported by columns (“bents” per the drawings). In addition to supporting the weight of the channel, the channel and the supporting bents must resist or distribute load from the concrete roof elements, and impulsive and sloshing fluid loads. This load path requires further study, as is discussed in greater depth below.

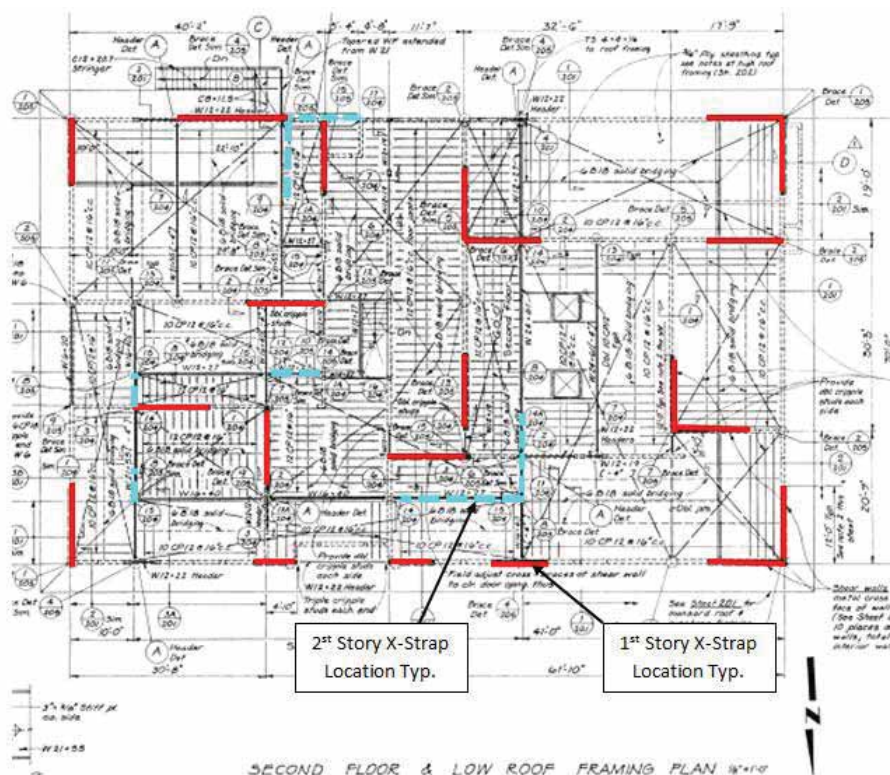
Figure 23: Control Building X-Strap Wall Locations

The building was constructed during the 1978 phase of construction, and has similar $\frac{3}{4}$ " plywood diaphragms with gauge metal straps at discrete locations to the FMC Maintenance building. Sheet metal X-bracing straps were originally designed to serve as the Control Building's seismic force resisting system. The locations of the sheet metal X-bracing straps are shown in Figure 23. Note how the bracing locations do not align.

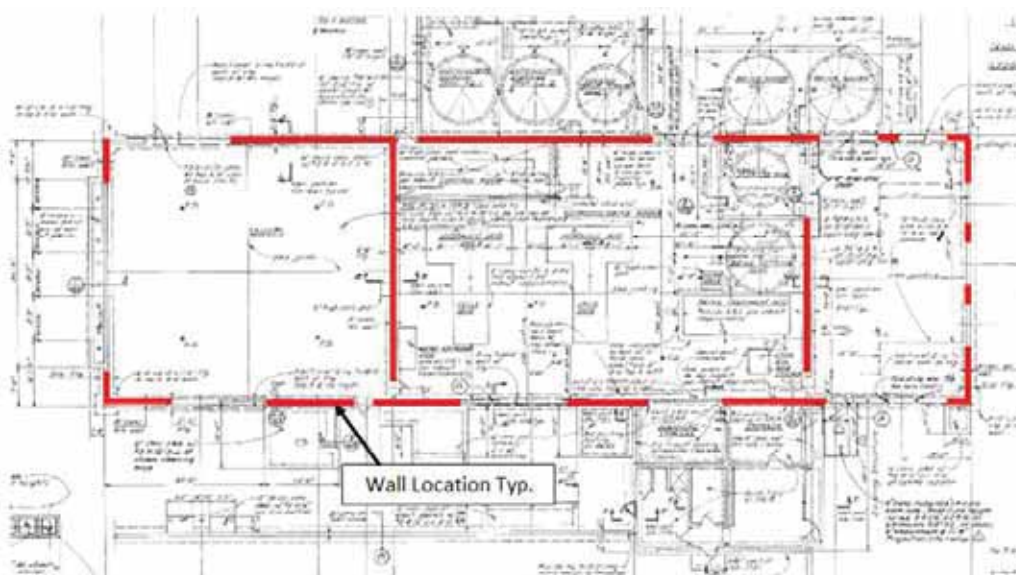
Figure 25: FMC Maintenance Building Reinforced Masonry Wall Locations

In a seismic event, the plywood diaphragms will transfer the load to the reinforced masonry shearwalls which are anchored to the concrete foundation. The masonry wall locations are shown in Figure 25. In buildings with heavy walls and light roofs, like the FMC Maintenance Building, most of the seismic damage is related to deficient anchorage between the heavy walls and the light roof diaphragm because the walls try to pull away from the diaphragm during an earthquake. The anchorage in the FMC Maintenance Building is more robust than many from its era, but it still is deficient as discussed below.

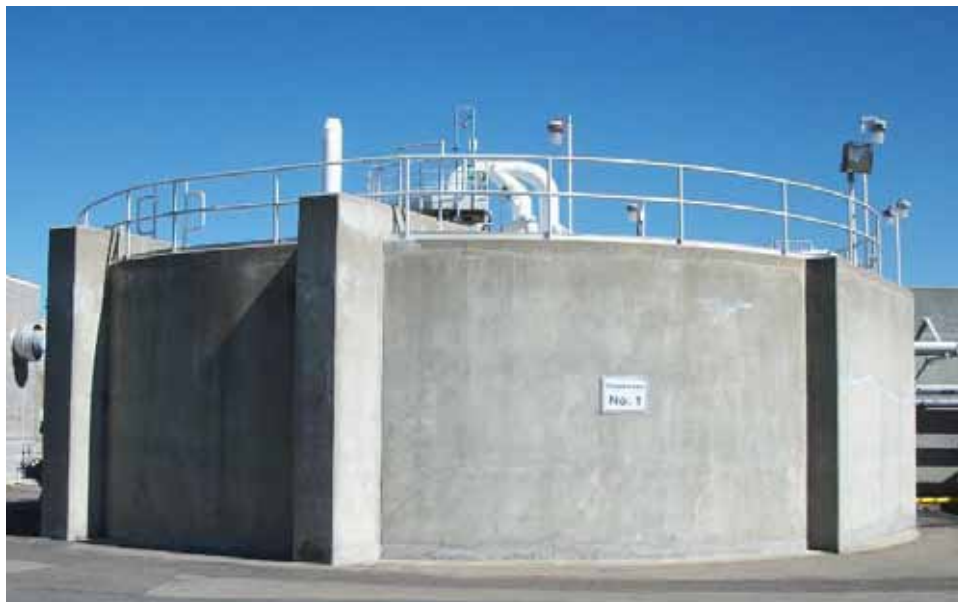
Figure 34: Exterior View of Thickener #1

Potential deficiencies are relatively minor and are discussed in greater detail below. However, note that from observations on our 3/18/14 site visit, there is substantial cracking in the walls of Thickener #1, particularly at the base of the wall. While the calculations contained in this report indicate that this cracking does not appear to be the result of structural distress, it's something that should be continually monitored.
