BOARD MEETING AGENDA
Monday, May 23, 2016
Regular Meeting - 7:00 P.M.

Union Sanitary District
Administration Building
5072 Benson Road
Union City, CA 94587

- Motion 10. Accept the Final Seismic Assessment Reports from Degenkolb Engineers *(to be reviewed by the Construction Committee)*.

Staff recommends the Board accept the final seismic assessment reports, dated April 22, 2016, from Degenkolb Engineers.

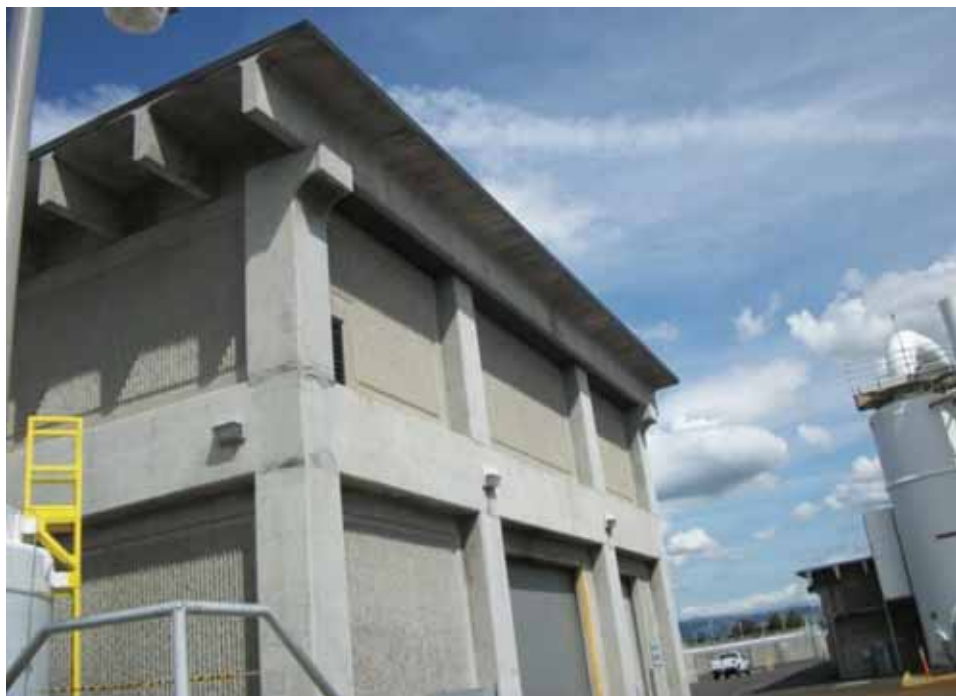
Figure 1: Exterior View of Degritter Building

The Degritter Building is a partially cast-in-place, partially precast concrete structure that was constructed during the 1985 phase of construction at the site. Figure 1 shows an exterior view of the Southwest corner of the Degritter building. The base slab, second floor slab and beam elements, column and pilaster elements, and interior first floor walls are cast-in-place elements. The exterior walls and roof structure are comprised of precast concrete elements. The precast concrete roof elements are not well tied into the walls below and are not well tied to each other. Therefore, they are not expected to perform well in a seismic event and pose a serious collapse hazard. These seismic deficiencies are discussed in greater detail below.

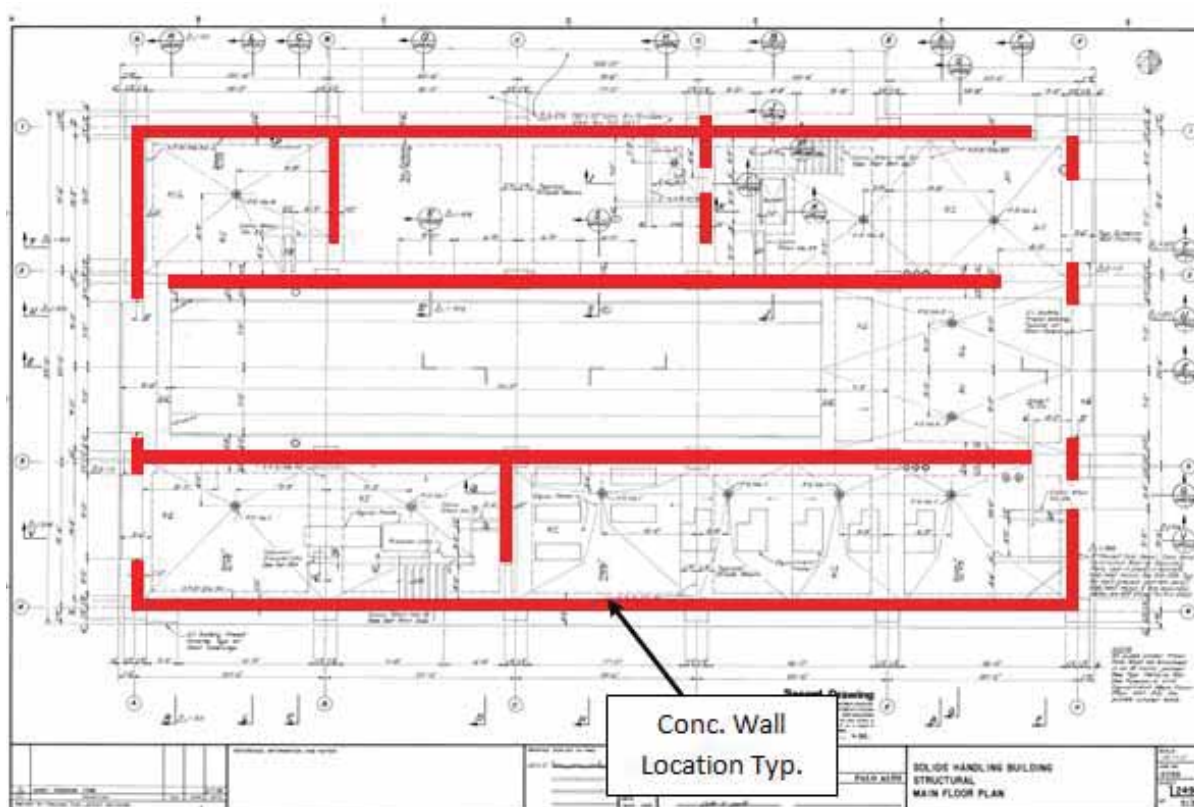
Figure 2: Degritter Building First Floor Concrete Wall Locations

The main lateral force resisting system of the Degritter Building is its concrete walls. The first floor concrete wall locations are highlighted in Figure 2.

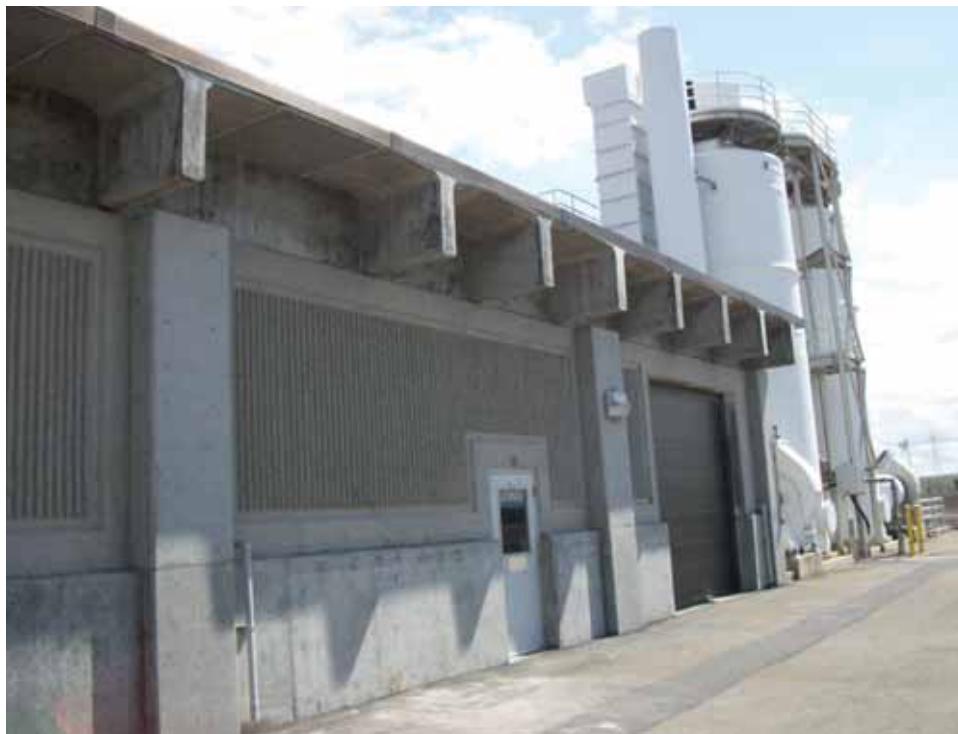
Figure 4: Exterior View of Primary Clarifiers 5-6/Pump Room #3

The Primary Clarifiers 5-6 and associated pump room #3 are partially cast-in-place, partially precast concrete structures that were constructed during the 1985 phase of construction. Figure 4 shows an exterior view of the pump room on the west side of Clarifiers 5-6, and includes a view of the odor scrubber towers that are supported off the clarifier roof. The construction of Primary Clarifiers 5-6 is very similar to the Degritter Building: the base slab, pilaster elements, and tank walls are cast-in-place elements. The exterior walls above grade and roof structure are comprised of precast concrete elements. The precast concrete roof elements are not well tied into the walls below and are not well tied to each other. Therefore, they are not expected to perform well in a seismic event and pose a potential collapse hazard. These seismic deficiencies are discussed in greater detail below.

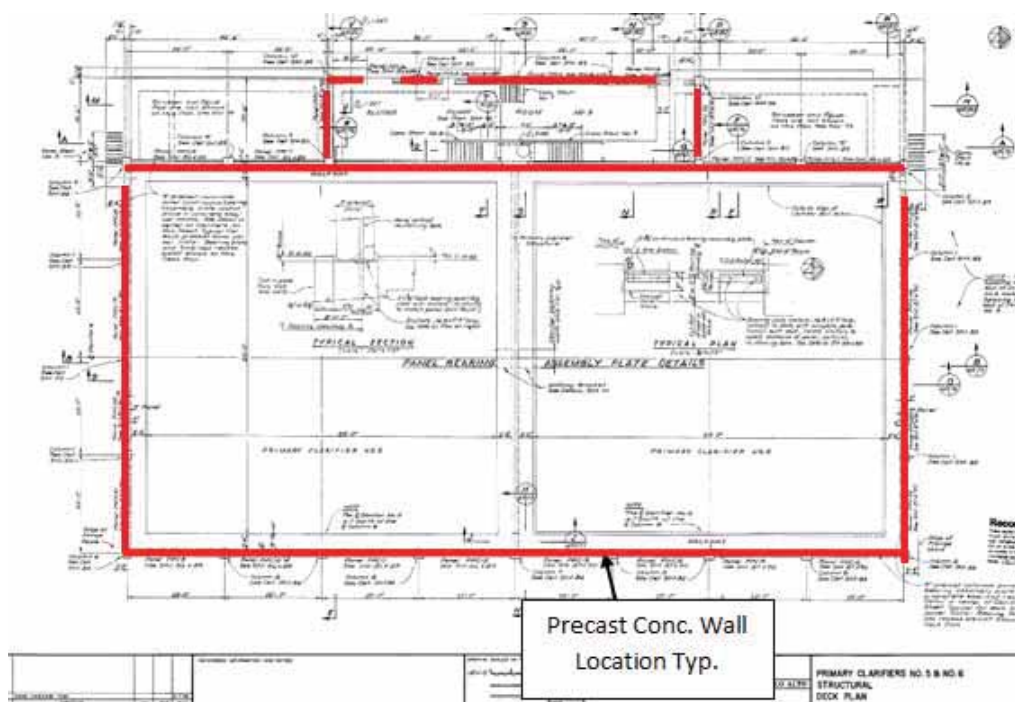
Figure 5: Primary Clarifiers 5-6 Precast Concrete Wall Locations

The primary system that resists inertial and incremental fluid loads of the clarifiers and pump room are the concrete walls. The precast concrete wall panels directly under the precast roof are highlighted in Figure 5.

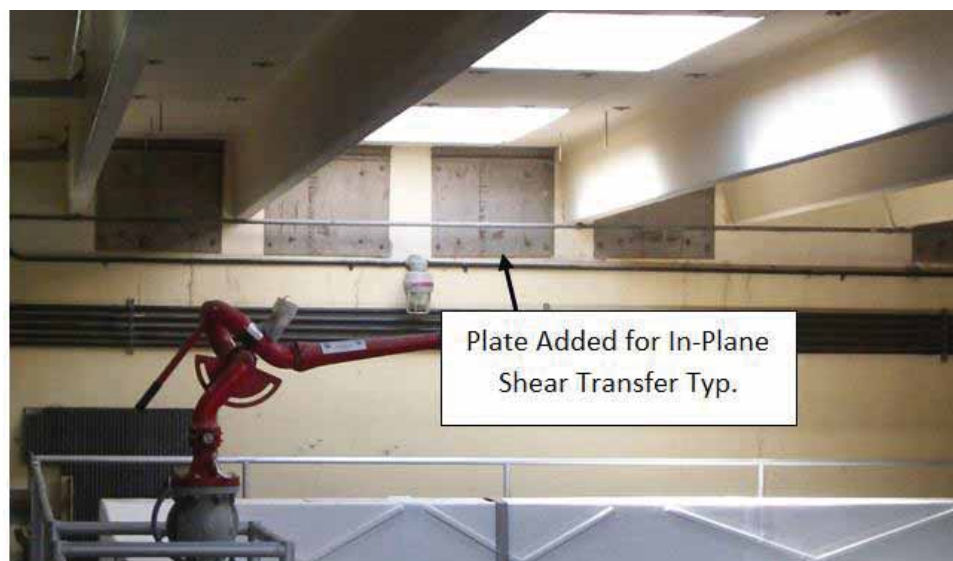
Figure 6: Portion of 1991 Structural Retrofit to Primary Clarifiers 1-4

The Primary Clarifiers 1-4 and the associated pump building are partially cast-in-place, partially precast concrete structures that were constructed during the 1978 phase of construction. The base slab, pilaster elements and tank walls are cast-in-place elements. The exterior walls above grade and roof structure are comprised of precast concrete elements. In the original 1978 construction, the precast concrete roof elements were not well tied into the walls below and were not well tied to each other. The clarifiers were seismically retrofitted in 1991 by Carollo Engineers to address some of the issues with the original 1978 construction. The plates added as part of the retrofit are shown in Figure 6. While these retrofits will definitely improve the performance of the clarifiers in a significant earthquake, the Primary Clarifiers 1-4 are still deficient for the DBE in many respects. These seismic deficiencies are discussed in greater detail below.

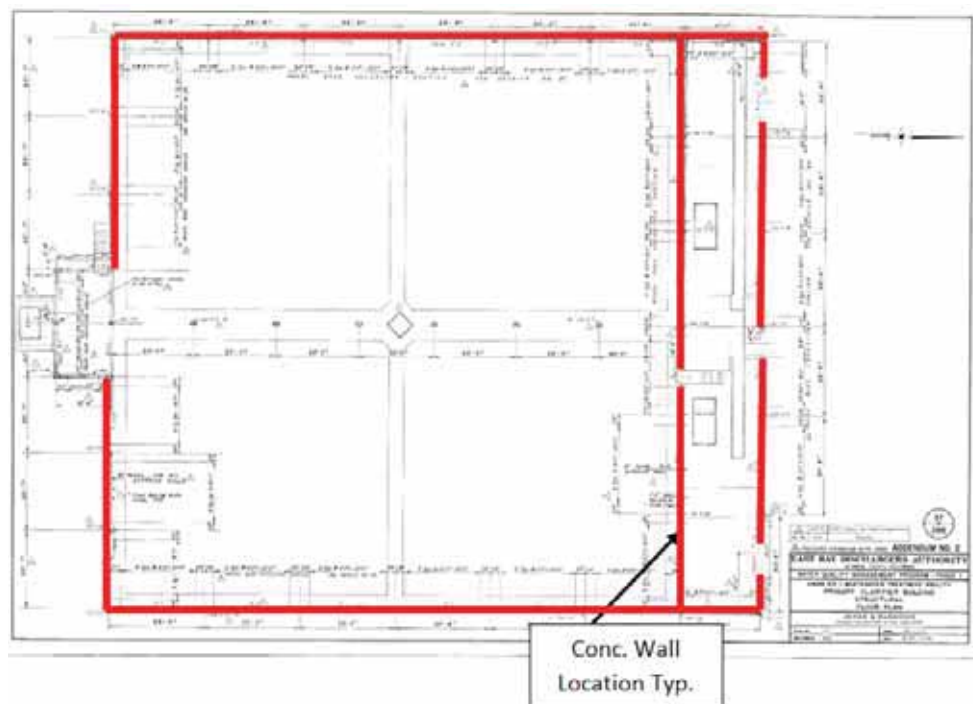
Figure 7: Primary Clarifiers 1-4 Precast Concrete Wall Locations

The primary system that resists inertial and incremental fluid loads of the clarifiers and pump room are the concrete walls. The precast concrete wall panels directly under the precast roof are highlighted in Figure 7.

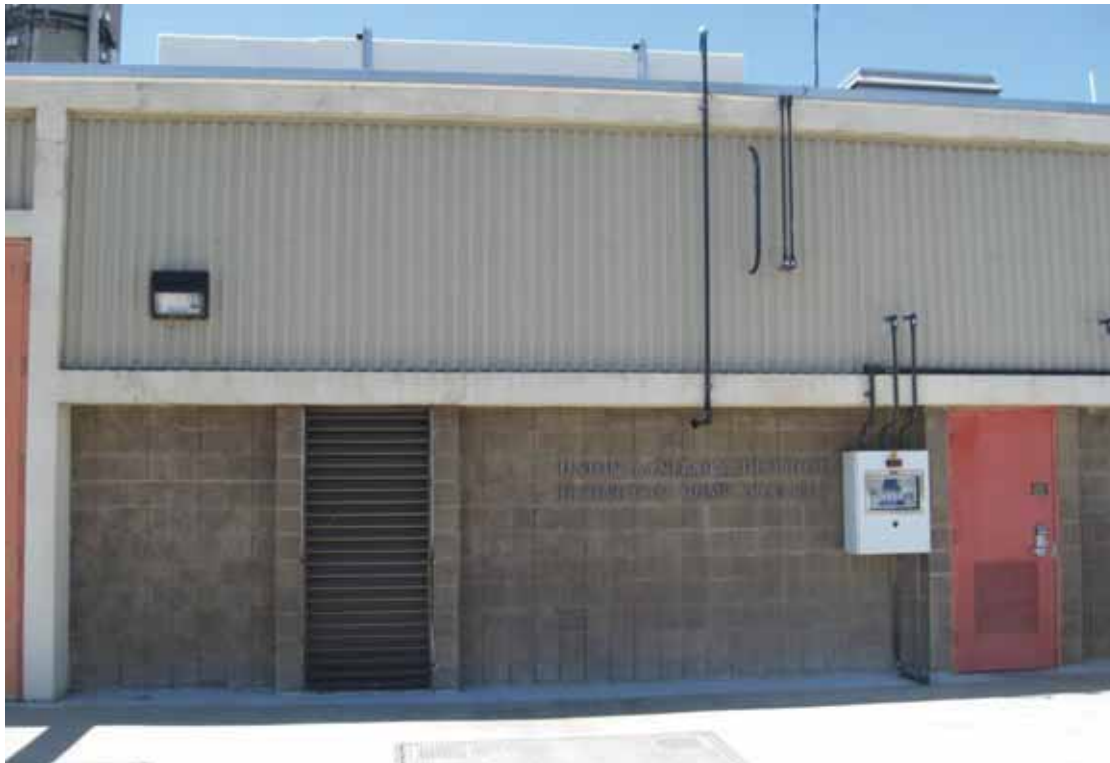
Figure 8: Exterior View of Irvington Pump Station

The Irvington Pump Station is a partially cast-in-place, partially reinforced masonry structure that was constructed during the 1978 phase of construction. It is located to the South of the main Union Sanitary Site. The pump station is a Three-story structure, with the first two floors below grade. An exterior view of the pump station is shown in figure 8. The base slab, second and third floor slabs and beam elements, and below grade walls are cast-in-place elements. The exterior walls above grade are reinforced masonry. Originally, the roof of the structure was comprised of precast double-t beams. However, this roof was replaced by a steel roof in 2001 as part of an expansion and retrofit project. The seismic detailing of the new roof structure has deficiencies which may cause the roof to collapse in the DBE. The seismic deficiencies are discussed in greater detail below.

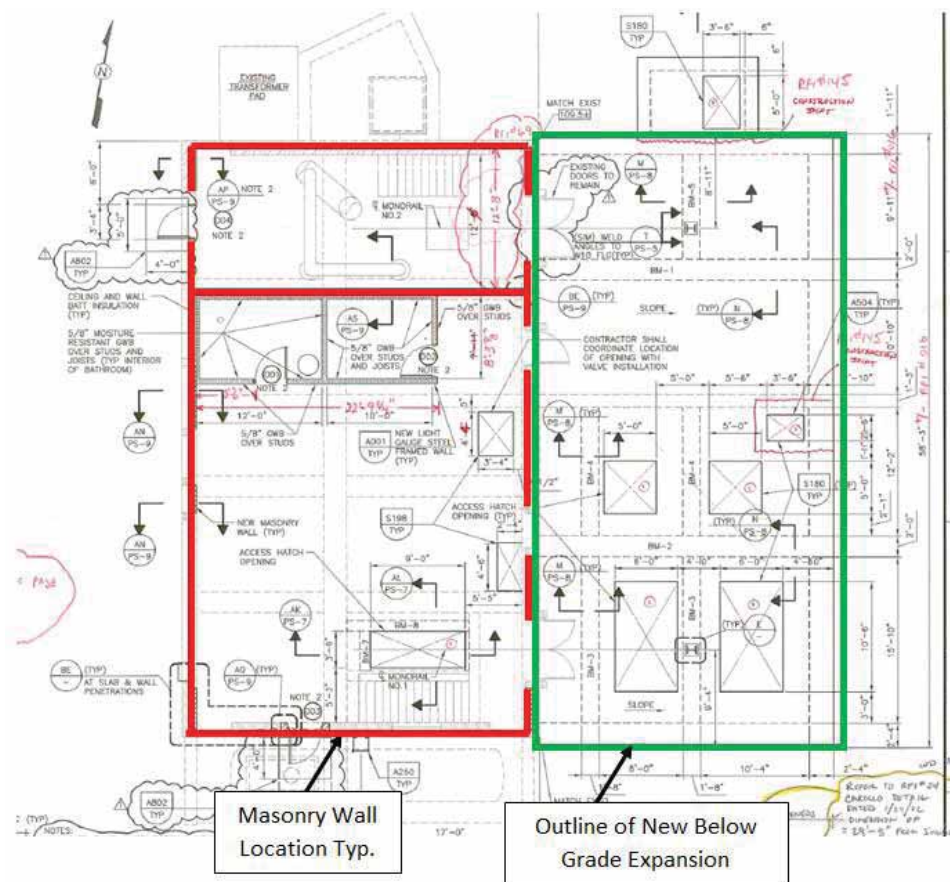
Figure 9: Irvington Pump Station Masonry Wall Locations and Expansion Extent

The main lateral force resisting system of the Irvington Pump Station is its concrete walls below grade, and its masonry walls above grade. The masonry walls above grade are highlighted in Figure 9. Note that the interior masonry wall was added as part of the 2001 retrofit and expansion project. The line work on the right hand portion of the plan are the below grade concrete beams and walls that form the new below grade structure that was added during the 2001 retrofit and expansion project.

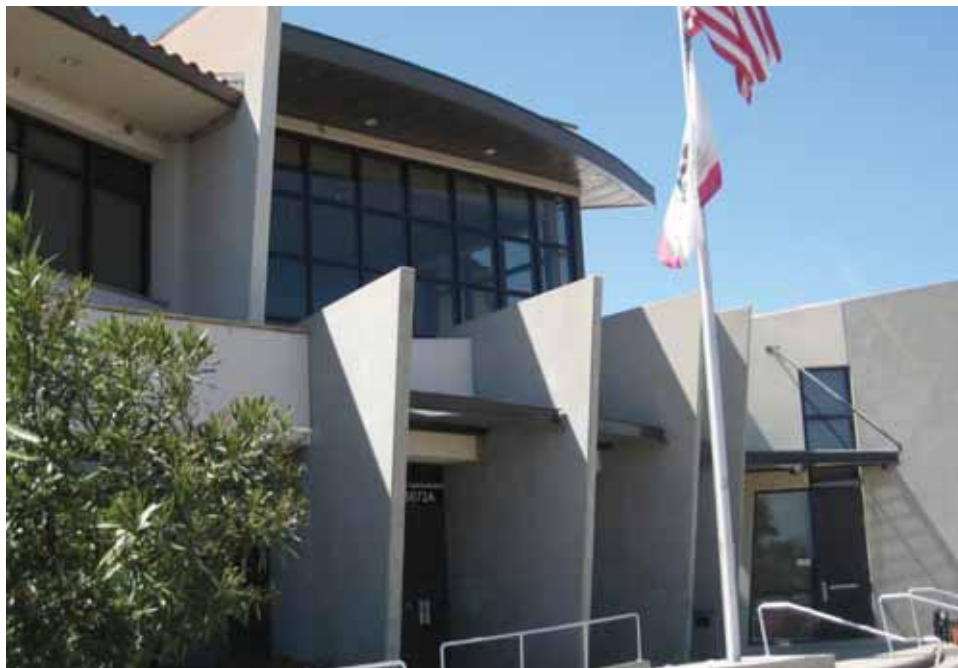
Figure 10: Exterior View of Administration Building

The Administration Building is a two-story structure built in 1999 using the 1994 Uniform Building Code. The structure is very geometrically and structurally complex; many different structural elements and materials are used to support the structure including rolled steel shape beams and columns, open web steel joists, dimensional timber beams, glue-laminated timber beams and precast concrete panels. The complex geometry can be seen from the exterior view of the Administration Building shown in Figure 10.

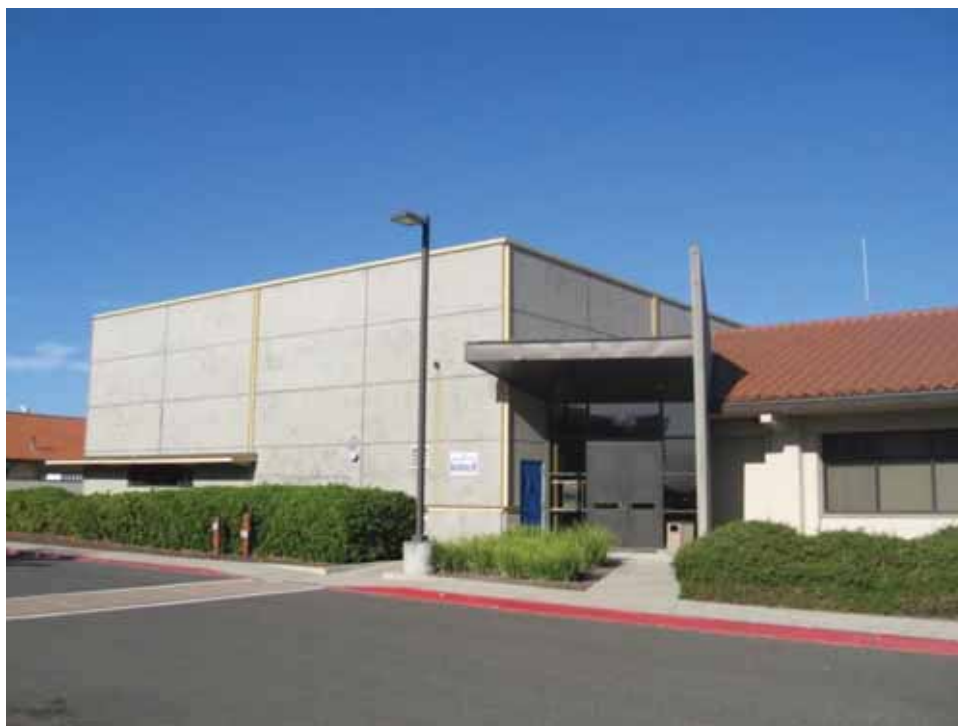
Figure 12: Exterior View of Field Operations Building

The Field Operations Building is comprised of two structurally separate, one-story buildings that were constructed in 1999 using the 1994 Uniform Building Code. One structure is a low-bay, wood framed structure with a plywood shearwall lateral system. The other structure is a high-bay wood framed structure with a precast concrete tilt-up wall lateral system. An exterior view showing both parts of the structure can be seen in Figure 12.

The locations of the plywood shear walls and precast concrete tilt-up walls are shown in Figure 13. As noted in greater detail below, the main deficiency of the Field Operations Building is the deficient connections between the precast concrete walls and the plywood diaphragms. These limited connections are not expected to perform well in the DBE. Furthermore, the structural separation between the two structures appears to be inadequate which could lead to pounding between the two structures. These deficiencies are discussed in greater detail below

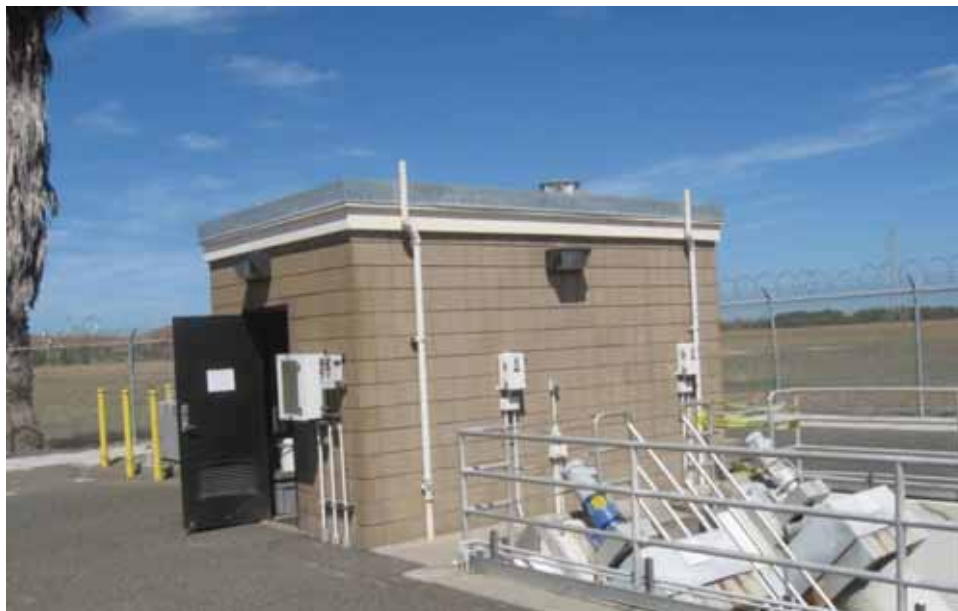
Figure 14: Exterior View of Paseo Padre Lift Station

The Paseo Padre Lift Station is comprised of two structures: a cast-in-place embedded structure below grade, and a separate small reinforced masonry structure above grade. The lift station was constructed during the 1985 phase of construction and is located to the South of the main Union Sanitary Site. An exterior view of the pump station is shown in Figure 14.

The main lateral force resisting system of the Paseo Padre Lift Station is concrete walls below grade, and masonry walls above grade. The masonry walls above grade and concrete walls below grade are highlighted in Figure 15. The main deficiency with the lift station is the lack of out-of-plane anchorage of the masonry walls, which is discussed in greater detail below.

With additional analysis to confirm the retrofit scope, it seems likely that the only major deficiency that needs to be addressed is the out-of-plane anchorage and cross-ties at the small roof. These deficiencies can be remediated with the addition of holdowns to the roof framing. We expect this retrofit to be simple and relatively inexpensive. We estimate the cost of this retrofit work to be on the order of \$50,000, with most of the cost relating to mobilizing a contractor to the site. Consequently, because we expect this to be a simple retrofit, we recommend completing the seismic retrofit concurrently with other work that needs to be done at the site.

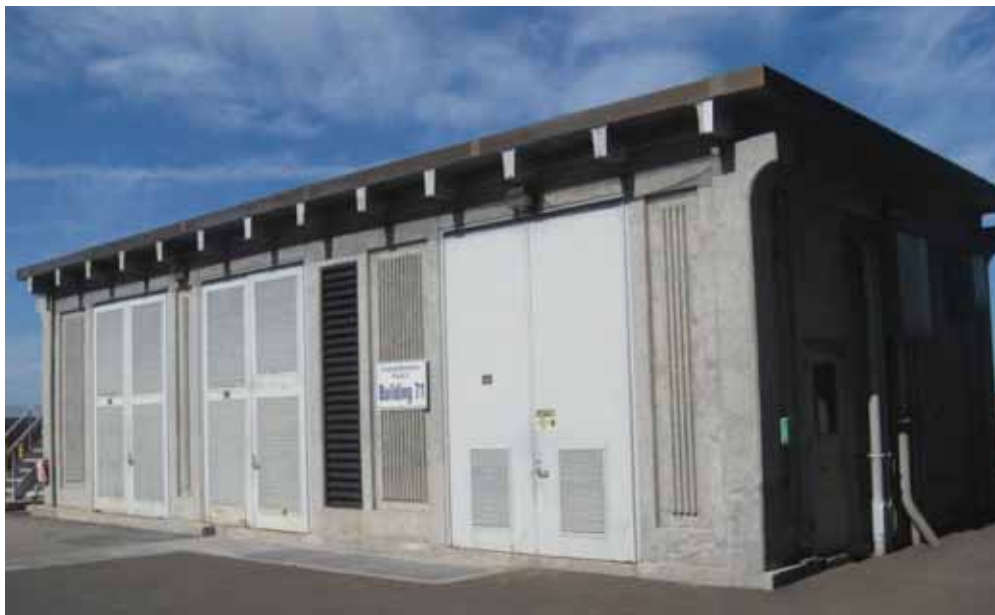
Figure 16: Exterior View of Generator Building #2

Generator Building #2 is a small one-story structure with cast-in-place walls and a precast concrete roof. This structure was constructed in 1988 and is shown in Figure 16.

The precast concrete roof is covered with a reinforced concrete topping slab which is tied down to the East and West concrete walls with dowels. The North and South concrete walls are tied to the roof beam stems with steel embed plates, and the center concrete wall is tied to the concrete roof beam stems with small steel angles. These concrete walls resist seismic induced forces and the wall locations are shown in Figure 17. Based on the preliminary screening, the main seismic deficiency of Generator Building #2 is related to overstressed connections between the diaphragm and the cast-in-place concrete walls, as discussed in further detail below.

The roof diaphragms are connected to the walls for shear transfer, but this load path is deficient. In the North-South direction, the dowels between the topping slab and concrete walls are slightly overstressed. In the East-West direction, no dowels are provided at the walls, so the inserts between the roof diaphragm beams have to transfer shear and are slightly overstressed. The embed attachments at the end walls are overstressed (300% DCR) and could break out of the concrete walls.

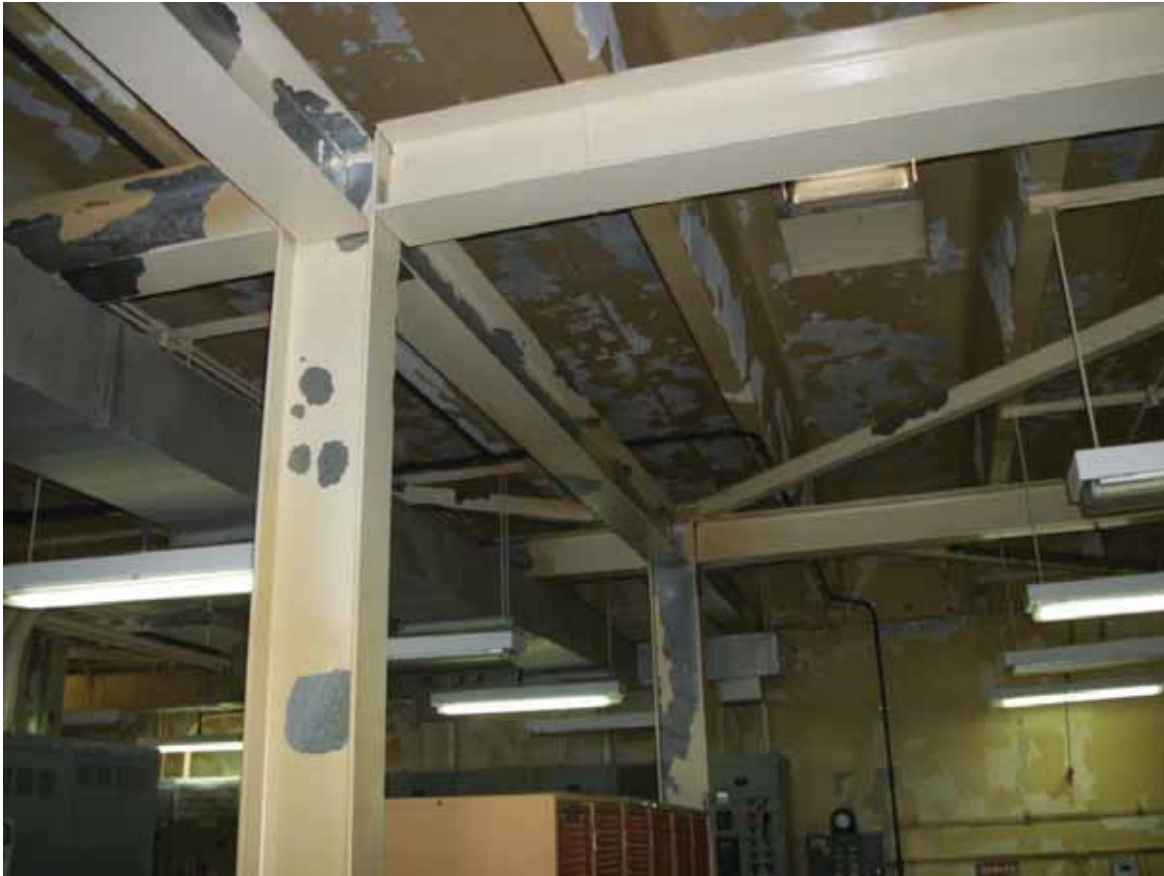
Figure 18: Alvarado Pump Station Retrofit Bracing

The Alvarado Pump Station is a partially cast-in-place, partially precast concrete structure that was constructed during the 1985 phase of construction. The pump station is a three-story structure, with the first two floors below grade. The base slab, second and third floor slabs and beam elements, column and pilaster elements, and below grade walls are cast-in-place elements. The exterior walls above grade and roof structure are comprised of precast concrete elements. In the original 1985 construction, which is very similar to the Degritter building, the precast concrete roof elements were not well tied into the walls below and were not well tied to each other. The Alvarado Pump Station was seismically retrofit in 2000 by Carollo Engineers to address some of the issues with the original 1985 construction. A view from the inside of the upper-story of the pump station showing the bracing added as part of the retrofit is shown in Figure 18. While the retrofits measures will enhance the seismic performance of the pump station, they did not mitigate all the seismic deficiencies. The possible deficiencies of the structure discussed in greater detail below.

The retrofit connections at the existing walls appear to be intended for in-plane seismic transfer but are deficient, especially at the North Wall. The new connections provided at the North Wall have a 700% DCR only considering the force from the diaphragm self-weight and the lowest possible roof acceleration. Note that the connections added at the middle wall appear to be different from what is shown on the retrofit drawings and require further study.

New retrofit connections to the East and West walls appear to only be provided at the East wall. From the original 1985 drawings the East wall is the end where the roof double-t girders are positively attached, so there appears to be no positive attachment at the West wall. Field exploration and testing are necessary to confirm the actual condition, as it may differ from what is shown in the original drawings. Still, even if the diaphragm were attached at both ends, the load path is almost certainly deficient because it relies on weak-way bending of the precast beam webs which will induce flexure into the thin diaphragm of the double-t beams.

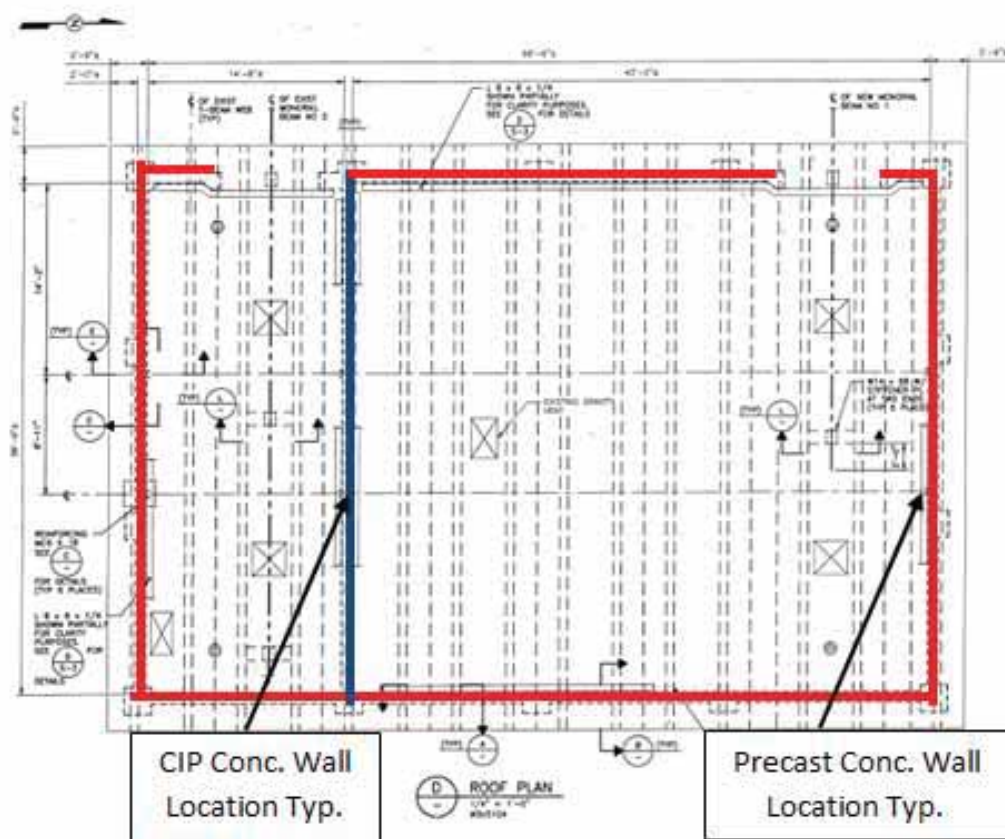
Figure 19: Alvarado Pump Station Concrete Wall Locations

The main lateral force resisting system of the Alvarado Pump Station is its concrete walls below grade, and its pre-cast and cast-in-place concrete walls above grade. The concrete walls above grade are highlighted in Figure 19.

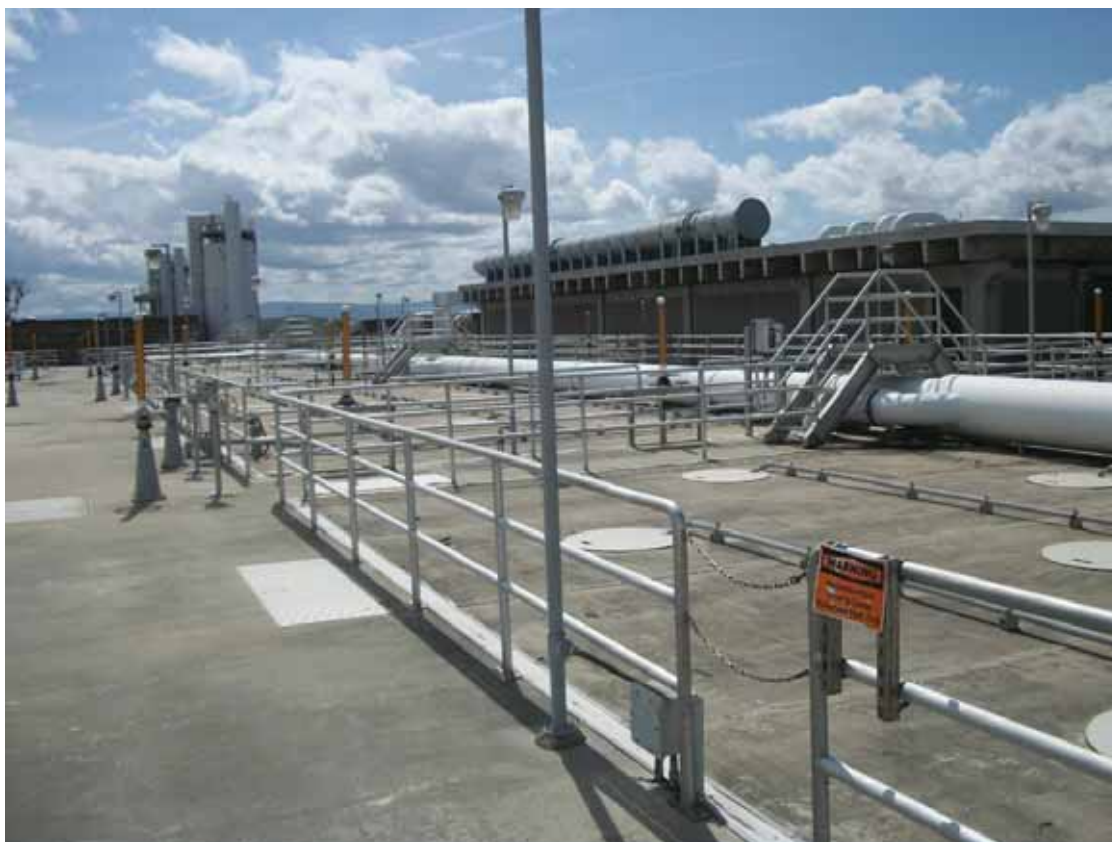
Figure 20: View of Aeration Basin Roof

Aeration Basins 1-4 is a cast-in-place, partially embedded concrete wall structure that is partially filled with fluids. This structure was constructed during the 1985 phase of construction on the site. The basins are structurally very similar to other square celled tank structures at the site (e.g. secondary clarifiers) except that the basins have a precast concrete beams that form a lid on the structure. The precast concrete beams are not positively connected to one another and are only tied into the center influent portion of the structure. This roof structure is not expected to perform well in a seismic event. A view from the roof of the basins showing the precast roof beams is shown in Figure 20.

For East-West seismic action, all of the load must be taken out at the center influent channel where the precast concrete beams are attached. For North-South seismic action, the roof diaphragm must cantilever from the end to which it is attached. The diaphragm elements are not positively connected to one another, so each double-T precast beam must cantilever its entire length. All of these actions are almost certainly deficient.

While this is not a life-safety hazard, it is possible the beams are damaged to the point where they fall into the tanks. Also localized pounding damage can be expected. The level of expected impact damage, however, is velocity dependent. The actual gap of the precast roof elements to the wall is only 1-2" based on site observations, which will limit velocities of the roof beams after the connections fail. Therefore, with further analysis it may be possible to show that impact related damage will be minimal.

It is our understanding that a new aluminum roof structure is being considered for the aeration basins. Installing a new lightweight roof would be a very effective way of dealing with the roof-related deficiencies and it would be beneficial from the perspective of reducing the mass of the roof structure (which would help protect the influent channels). Without conducting further, more analytically complex, studies however, it is difficult to know whether or not strengthening of the influent channels will be required. If strengthening of the influent channels is required, we would expect it to be a fairly expensive undertaking that would require temporarily draining the basins. Assuming that limited strengthening is needed at the intersection of the channels and including the replacement cost of a lightweight roof, we estimate the retrofit cost will be on the order of \$75 per square foot.

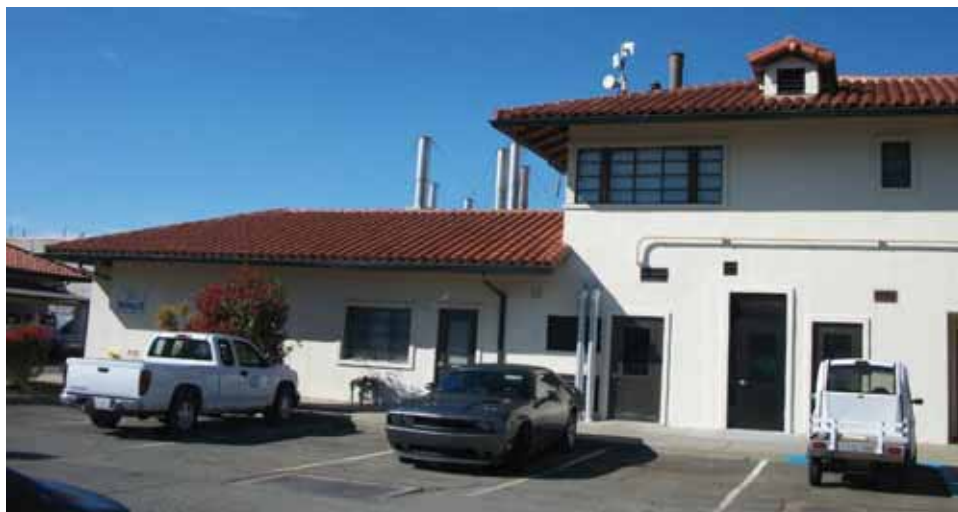
Figure 22: Exterior View of Control Building

The control building is a light cold-form steel framed partial two-story structure. The structure has a complex pitched, Spanish Clay Tile clad roof. An exterior view of the Control Building

is shown in Figure 22. This Spanish Clay Tile roof is heavy and adds a significant amount of seismic mass to the otherwise light structure.

As noted in the deficiencies below, these straps are likely more flexible than the exterior stucco walls and interior gypsum board walls. Therefore, the strap walls will likely only be engaged after the other walls have sustained some level of damage. In a seismic event, the plywood diaphragms will transfer the inertial load to the various walls in the Control Building, which will ultimately transfer the loads to the foundation. Typically, light-framed, low-rise structures like the Control Building perform well in seismic events. However, due to the many discontinuities in the lateral system, and because of its heavy roof, the Control Building may not perform as well in the design seismic event as other light-framed structures. These potential deficiencies are discussed in greater detail below.

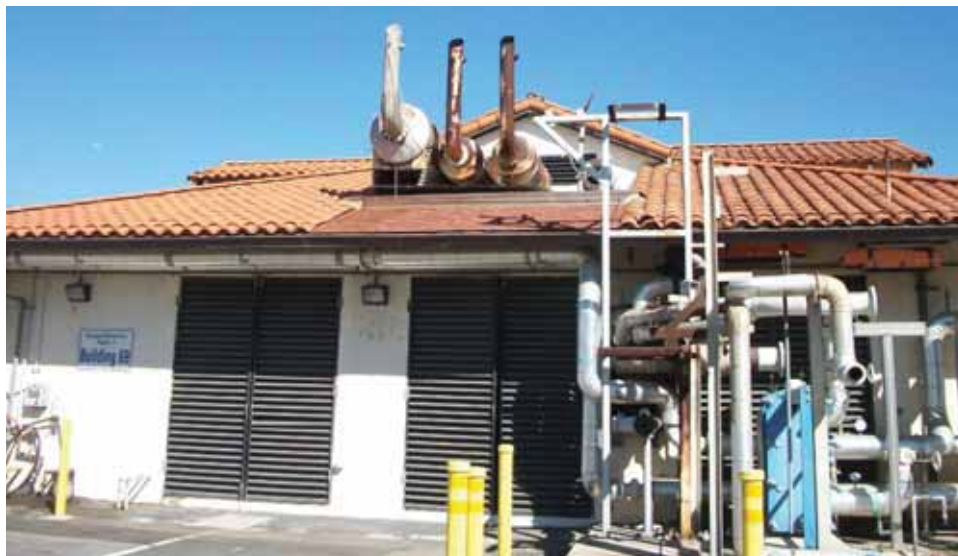
Figure 24: Exterior View of FMC Maintenance Building

The FMC Maintenance/Generator Building is a reinforced masonry bearing wall structure with a pitched, Spanish Clay Tile clad roof. The roof is supported by steel trusses and cold-formed steel joists. An exterior view of the FMC Maintenance Building is shown in Figure 24. The structure was constructed primarily during the 1978 phase of construction, and was an addition to a much smaller cast-in-place reinforced concrete structure which was originally constructed in the early 1960's. The roof is sheathed with a lightly screwed ¾" plywood diaphragm and is strapped with gauge metal straps at discrete locations.

In a seismic event, the plywood diaphragms will transfer the load to the reinforced masonry shearwalls which are anchored to the concrete foundation. The masonry wall locations are shown in Figure 25. In buildings with heavy walls and light roofs, like the FMC Maintenance Building, most of the seismic damage is related to deficient anchorage between the heavy walls and the light roof diaphragm because the walls try to pull away from the diaphragm during an earthquake. The anchorage in the FMC Maintenance Building is more robust than many from its era, but it still is deficient as discussed below.

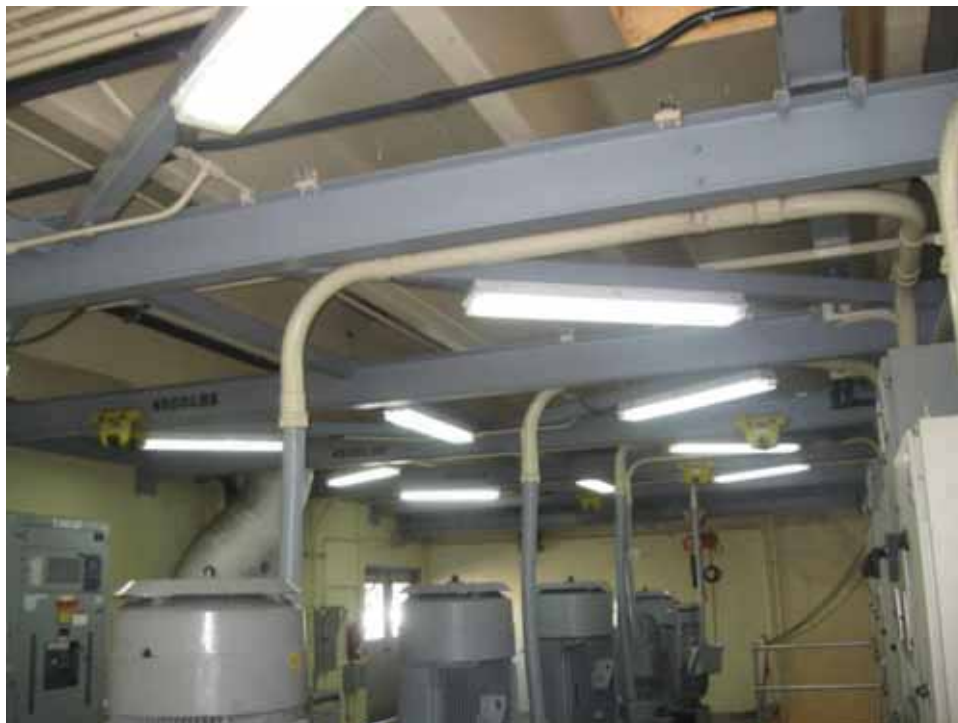
Figure 26: EBDA Pump Station Retrofit Bracing

The EBDA Pump Station/Reclaim Water Room is a partially cast-in-place, partially precast concrete structure that was constructed during the 1978 phase of construction. The pump station is a two-story structure, with the bottom-story below grade. The base slab, second floor slab and beam elements, column and pilaster elements, and below grade walls are cast-in-place elements. The exterior walls above grade and roof structure are comprised of precast concrete elements. In the original 1978 construction, which is very similar to Primary Clarifiers 1-4, the precast concrete roof elements were not well tied into the walls below and were not well tied to each other. The pump station was seismically retrofit in 1995 to address some of the issues with the original 1978 construction. A view from the inside of the upper-story of the pump station showing the bracing added as part of the retrofit is shown in Figure 26. While the retrofits measures will enhance the seismic performance of the pump station, they did not mitigate all the seismic deficiencies. The possible deficiencies of the structure discussed in greater detail below.

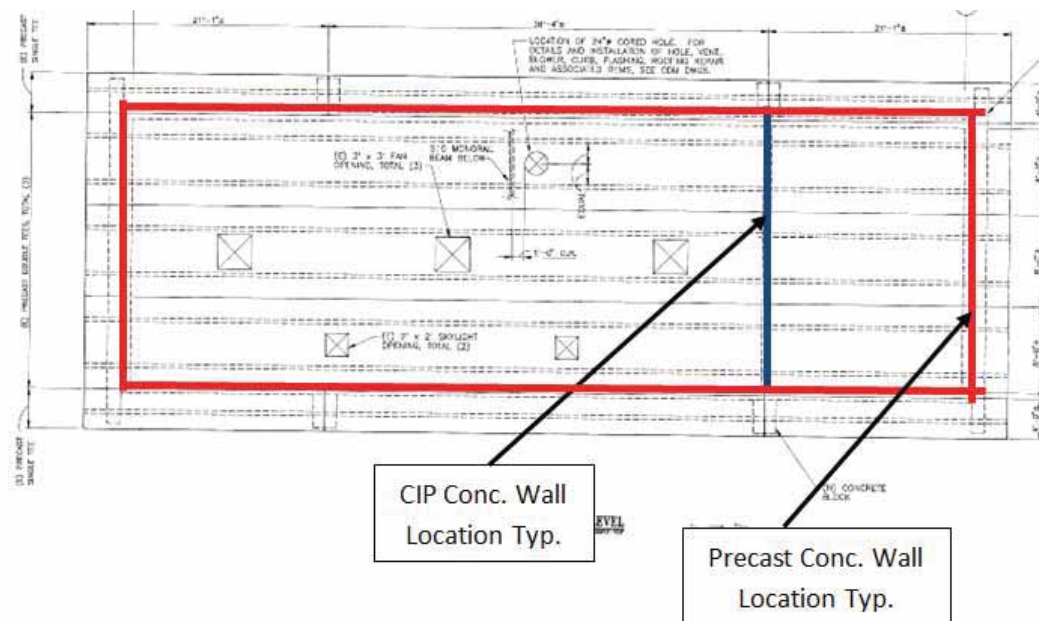
Figure 27: EBDA Pump Station Concrete Wall Locations

The main lateral force resisting system of the EBDA Pump Station is its concrete walls below grade, and its pre-cast and cast-in-place concrete walls above grade. The concrete walls above grade are highlighted in Figure 27.

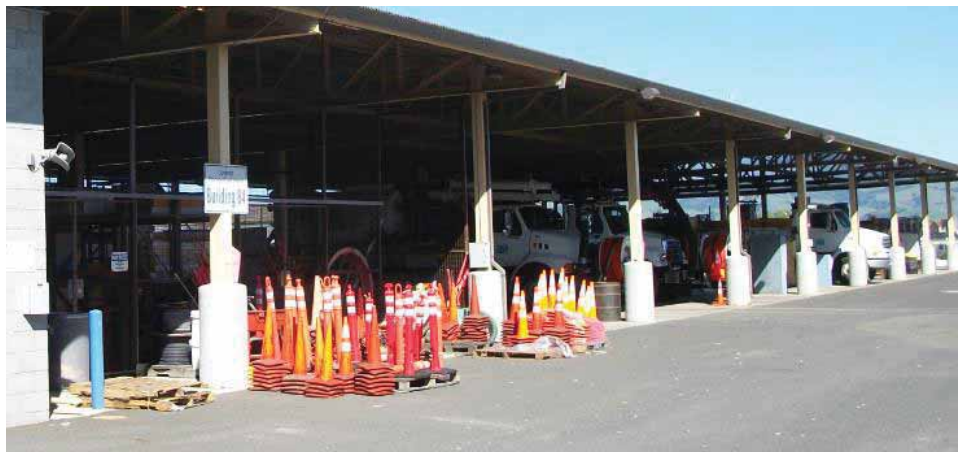
Figure 28: Exterior View of Covered Storage Building

The covered storage building is a lightweight open steel structure supported by cantilevered columns. An exterior view of the covered storage structure is shown in Figure 28. The building was constructed in 2000 and was designed to the 1994 Uniform Building Code. Because the columns cantilever from the base supports for seismic resistance, the covered storage structure is very flexible structure. A small reinforced masonry mezzanine structure is located at the West end of the covered storage structure. Although the mezzanine is structurally independent of the steel covered storage structure, it is not isolated from the covered storage structure and the two may interact in a seismic event because of the flexibility of the covered storage structure. The column locations and reinforced masonry wall locations are shown in Figure 29.

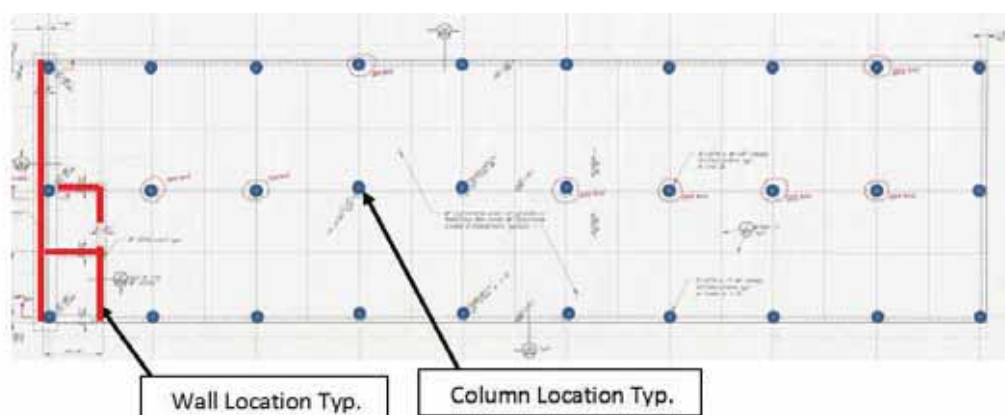
Figure 29: Covered Storage Building Column and Masonry Wall Locations

The findings, as noted below, assume that the columns are positively connected to the concrete bollard pedestals that protect the base of the columns from vehicle impacts. The findings also assume that the bollard pedestals are doweled into the foundations. Because there is no information on the structural drawings regarding these issues, it is recommended that destructive and/or non-destructive tests be conducted to make these determinations. If it is found that the bollards are not positively connected and/or doweled, the drift levels and damage discussed below will increase. The columns will also very likely be overstressed if they are not positively connected to the bollard pedestals.

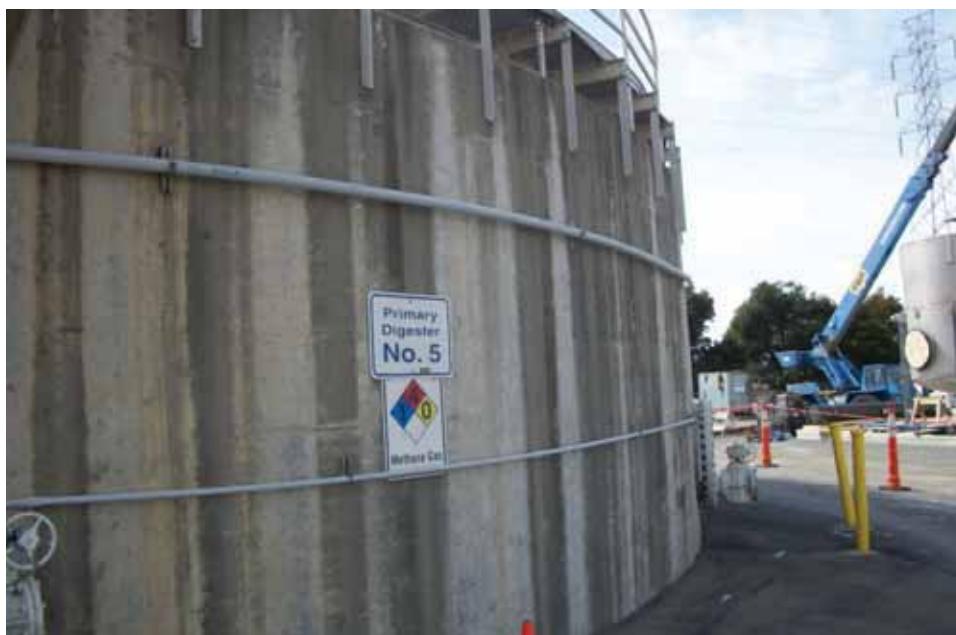
Figure 30: Exterior View of Primary Digester #5

Primary Digester #5 is a round cast-in-place concrete tank structure with a steel dome that was constructed during the 1985 phase of plant construction. An exterior view of the digester is shown in Figure 30. The steel dome is usually under positive pressure from the gasses within the tank, and is held down by steel tube supports and anchors along the perimeter of top of the tank.

During the seismic event, the fluid within the tank will be accelerated, which will place shear stresses and additional hoop stresses on the circular concrete wall. Similarly, the earthquake will put additional stresses on the HSS anchors that support the steel roof, and it will put additional stresses on the concrete tube column in the center of the tank. While the tank walls and roof anchorage are robust, the seismic induced stresses in these elements are high and further analysis is recommended to determine how they will perform in a seismic event. Possible deficiencies are noted below.
