BOARD MEETING AGENDA
Monday, May 23, 2016
Regular Meeting - 7:00 P.M.

Union Sanitary District
Administration Building
5072 Benson Road
Union City, CA 94587

- Motion 10. Accept the Final Seismic Assessment Reports from Degenkolb Engineers *(to be reviewed by the Construction Committee)*.

Staff recommends the Board accept the final seismic assessment reports, dated April 22, 2016, from Degenkolb Engineers.

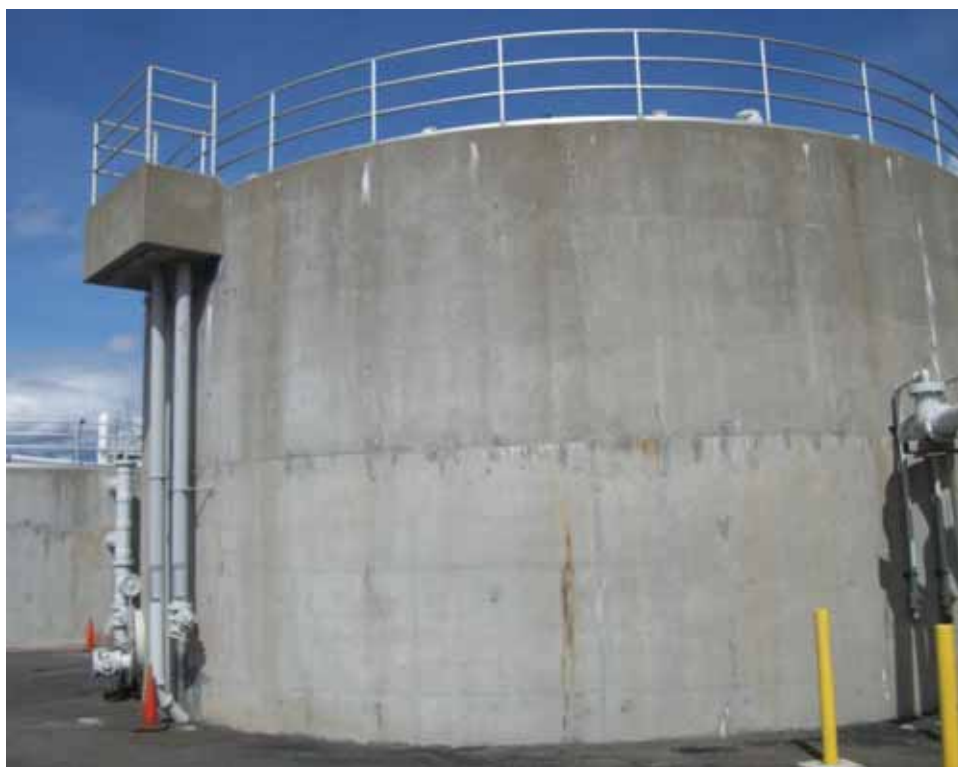
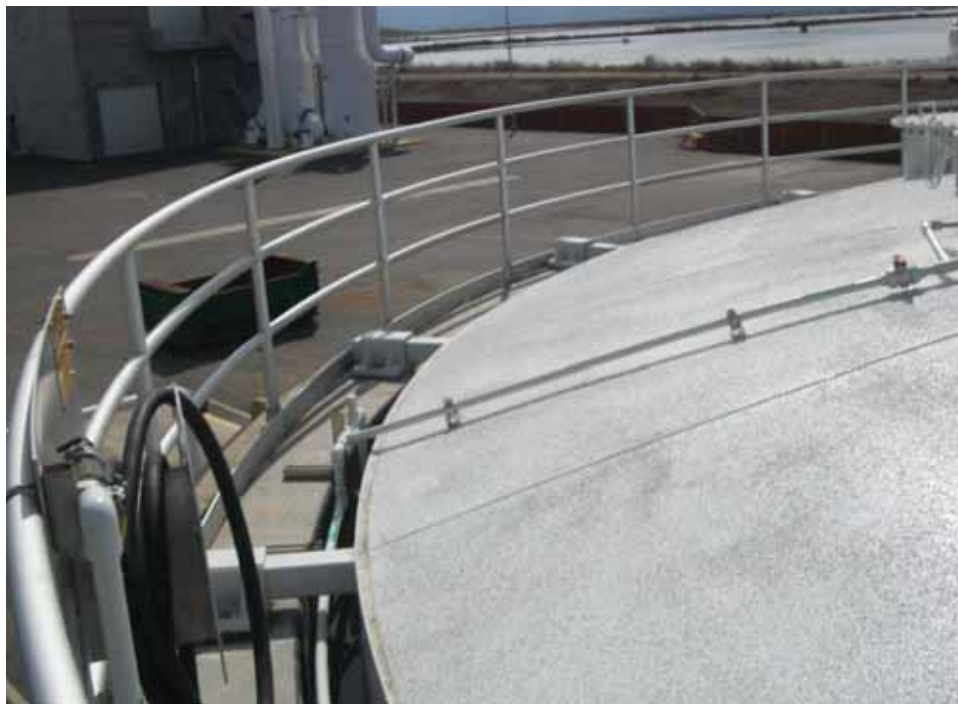
Secondary Digester #1 is a round cast-in-place concrete tank structure with a steel dome that was constructed during the 1978 phase of plant construction. The steel dome and support attachments were replaced in 2011. A view of Secondary Digester #1 and its steel dome can be seen in Figures 31 and 32. The steel dome is usually under positive pressure from the gasses within the tank, and is held down by steel tube supports and anchors along the perimeter of top of the tank.

During a seismic event, the fluid within the tank will be accelerated, which will place normal shear stresses and additional hoop stresses on the circular concrete wall. Similarly, the earthquake will put additional stresses on the HSS anchors that support the steel roof. The seismic induced stresses in these elements are high and further analysis is recommended to determine how they will perform in a seismic event. Possible deficiencies are noted below.

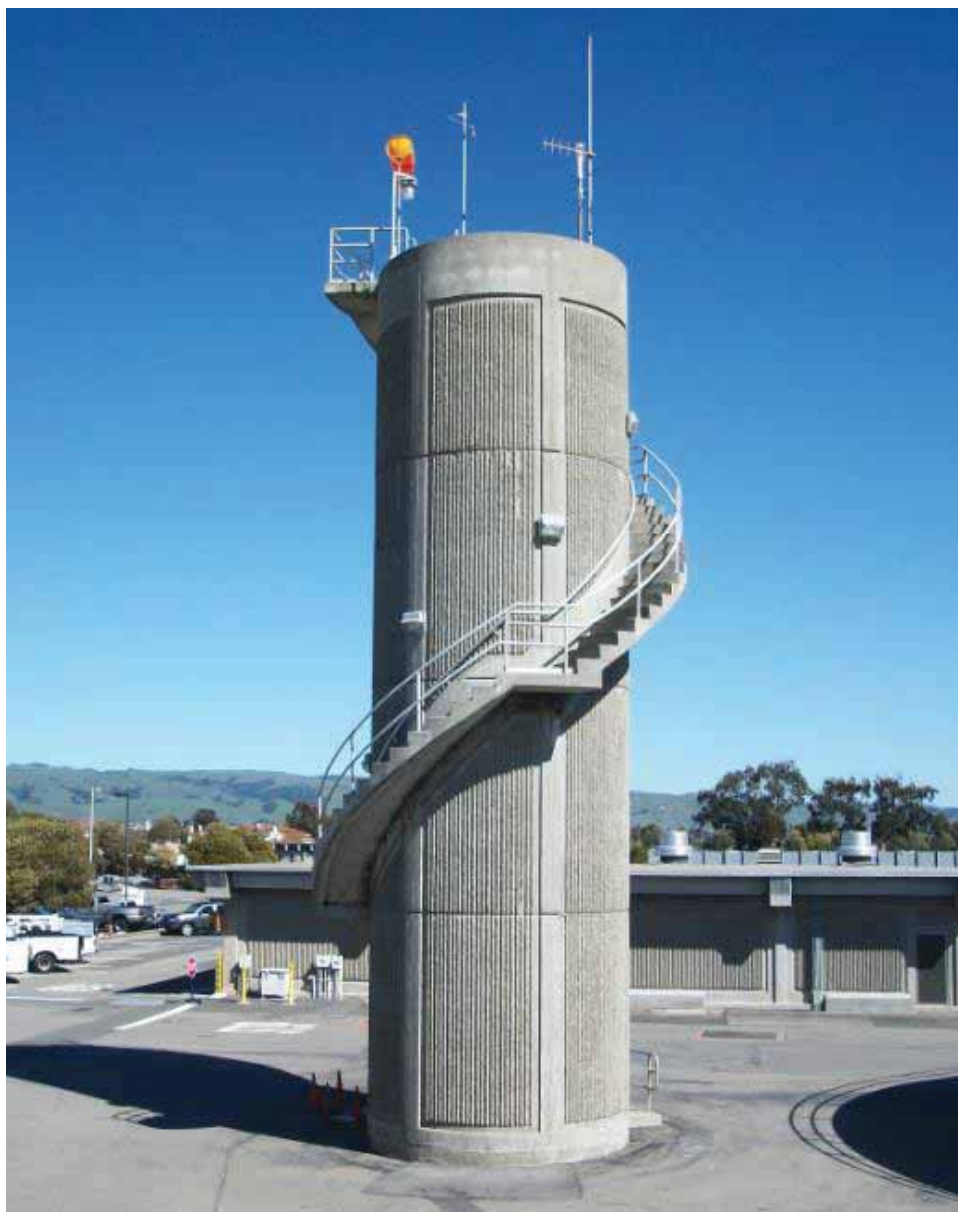
Figure 33: Exterior View of EBDA Effluent Surge Tower

The EBDA Surge Tower is a tall, narrow, cast-in-place concrete tower constructed during the 1978 phase of construction at the site. An exterior view of the Surge Tower is shown in Figure 33. A large 60” diameter pipe exits the tower near its base, which is located approximately 15 feet below grade. The walls of the tower are thick and are well reinforced, and the tower is founded on a 2-foot thick 25-foot square reinforced concrete mat foundation. In a significant seismic event, the walls will work to distribute the seismic induced inertial and fluid forces to the foundation and into the surrounding soil.

It is our understanding that the height of the fluid in the tower varies significantly. Consequently, we have conducted preliminary analyses considering the fluid height at a full level (near the top platform) and at half level. For a given seismic event, the performance of the tower will be largely dependent on the level of the fluid within the tank, and how the surrounding soil at the base of the tank responds to the movement of the tank. Note that for all of our preliminary analyses, the potential beneficial effect of the surrounding soil has been neglected. This has been done because building codes require geotechnical engineering input on a structure by structure basis to assess potential seismic soil pressures. For many of the structures at the site (mostly partially embedded tank structures like the primary clarifiers), it is unclear to us whether or not the movement near the base of the structures will be significant enough for seismic induced passive soil pressures to develop. For the EBDA Surge Tower, however, an appreciable amount of movement is expected and it is likely that the soil will have a beneficial effect on the seismic performance of the tower. Consequently, further analysis and geotechnical input is recommended.

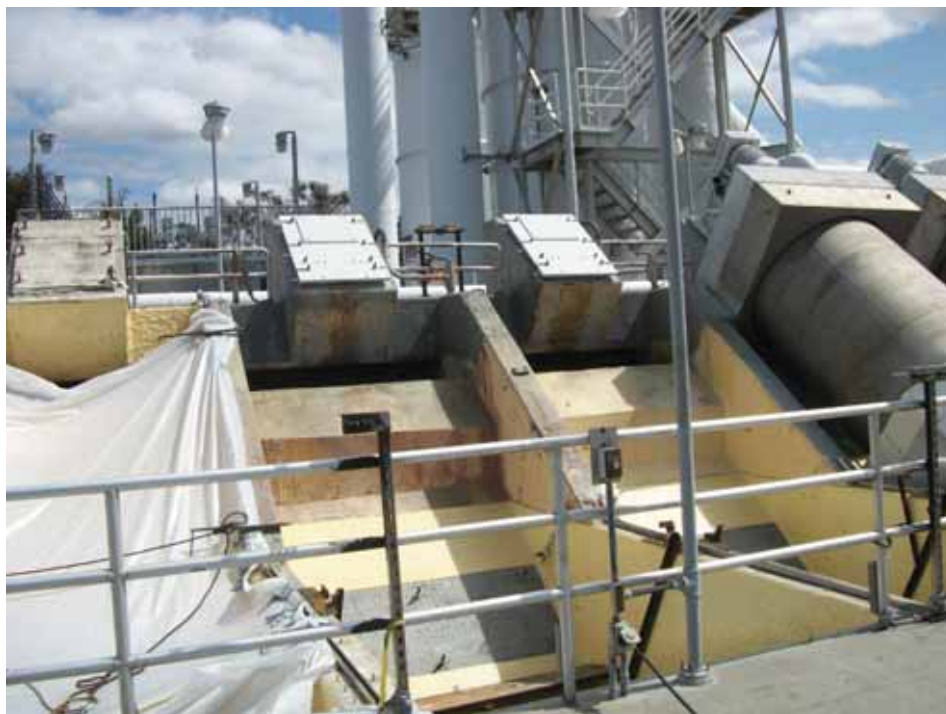
Figure 35: Exterior View of Lift Station #1

Lift station 1 is a cast-in-place, partially embedded concrete structure constructed during the 1985 phase on construction. An exterior view of Lift Station #1 is shown in Figure 35. The lift station walls are thick and are well reinforced. The structure supports very heavy steel pumps, which pump fluid from a channel on the west side of the structure to a channel on the east side of the structure.

In seismic events, cast-in-place concrete structures with high amounts of wall like the lift station tend to perform very well. The lift station would be expected to perform very well in a seismic event, except that there are some potential load path deficiencies regarding how the horizontal diaphragm elements are connected to the concrete walls that require further study. These potential deficiencies are discussed in greater detail below.

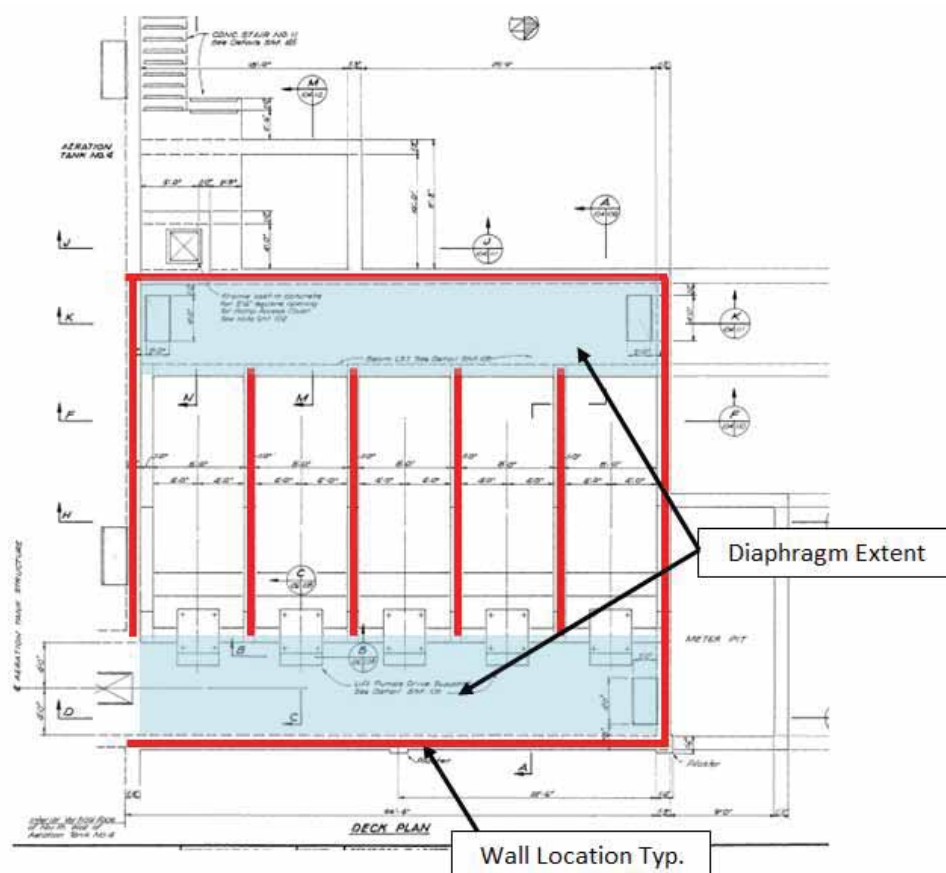
Figure 36: Lift Station #1 Concrete Wall and Concrete Diaphragm Locations

Also, the short roof diaphragms at the top East level and intermediate west level must cantilever for North-South seismic action. This is likely not a deficiency with further analysis, but needs further study because of the large mass of the pumps and because the cantilever moment reactions must be resisted by small amount of reinforcing/continuity into the cross walls.

The location of the main diaphragms and load resisting concrete walls are shown in Figure 36 below.

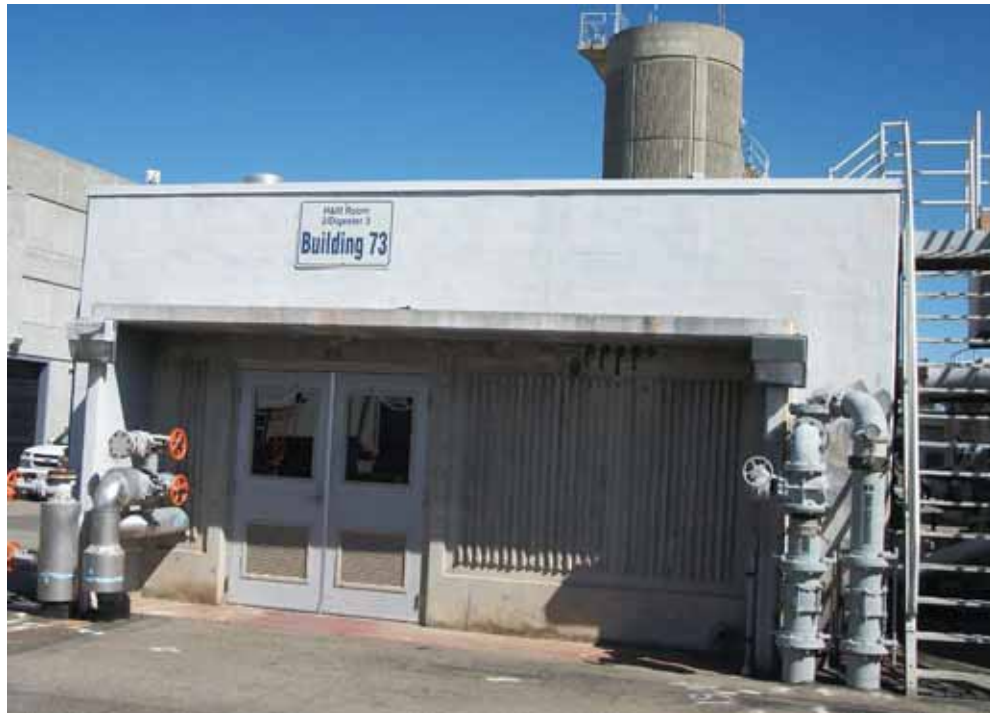
Figure 37: Exterior View of Heat Mix Building #2

Heat Mix Building #2 is a small cast-in-place structure that was constructed in the 1960's. An exterior view of Heat Mix Building #2 is shown in Figure 37. During the 1978 phase of construction, concrete infill panels were added on the East and West open portions of the structure. The 1978 drawings indicate that these concrete panels were doweled into the spandrel beam above and the concrete foundation below, which would indicate that the panels were cast-in-place. However, the existence of dowels should be verified with testing in the field. A plan showing the locations of the cast-in-place concrete walls, and infilled precast concrete panels is shown in Figure 38. Furthermore, despite the fact that the detailing is non-ductile as typical of 1960's vintage concrete buildings, we expect the heat mix building to perform well from a life-safety perspective in the DBE because of its small size.

As noted below, the only potential ASCE 41-13 identified deficiency that poses a significant life-safety concern (other than typical building deficiency of piping attachment) is related to the walkway that connects the Heat Mix Building #2 to Primary Digester #3. This deficiency is really a non-structural issue and would only pose a life-safety concern if someone was on or below the walkway.

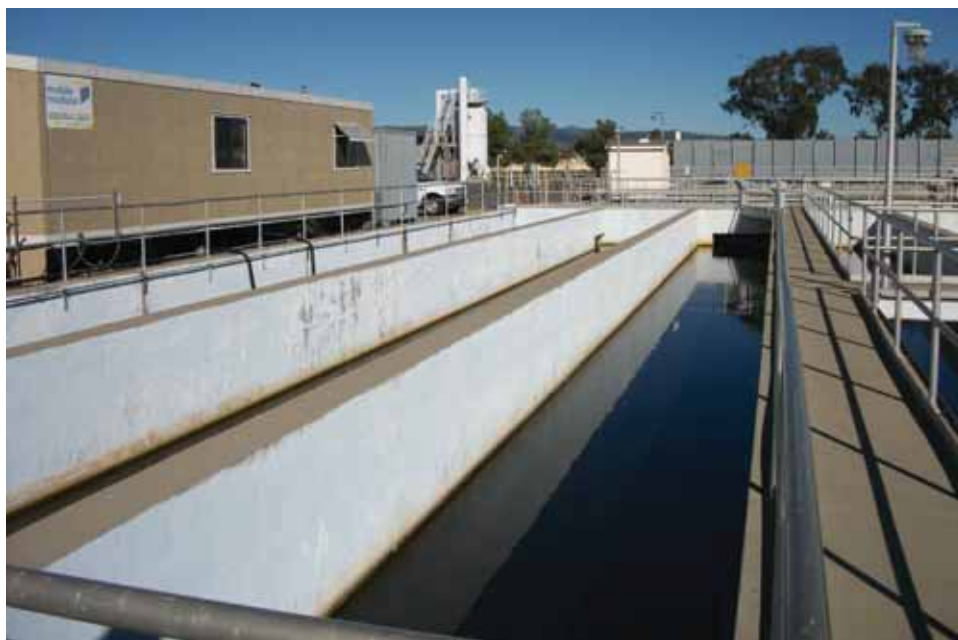
Figure 39: Exterior View of Chlorine Contact Tank

The Chlorine Contact Tank is a series of open-air narrow channels formed by robust cast-in-place, mostly below grade concrete walls. A view of the contact tank is shown in Figure 39. The tank was constructed during the 1978 phase of construction at the site, and sits adjacent to Secondary Clarifiers 1-4 and the Effluent Pump Station. The main potential life-safety deficiency, as discussed below, does not relate to the Chlorine Contact Tank but rather to the adjacent Effluent Pump Station.

The walls of the Chlorine Contact Tank have been preliminarily analyzed for the incremental fluid and inertial forces from the DBE. The thick exterior walls are sufficient to resist the incremental pressure, and the thinner interior walls are sufficient to resist the forces but are highly stressed compared to the exterior walls. Consequently it is possible that a flexural hinge could form at the base of an interior wall during a significant seismic event (some ground motion larger than what is produced by the DBE), causing the wall to partially collapse.

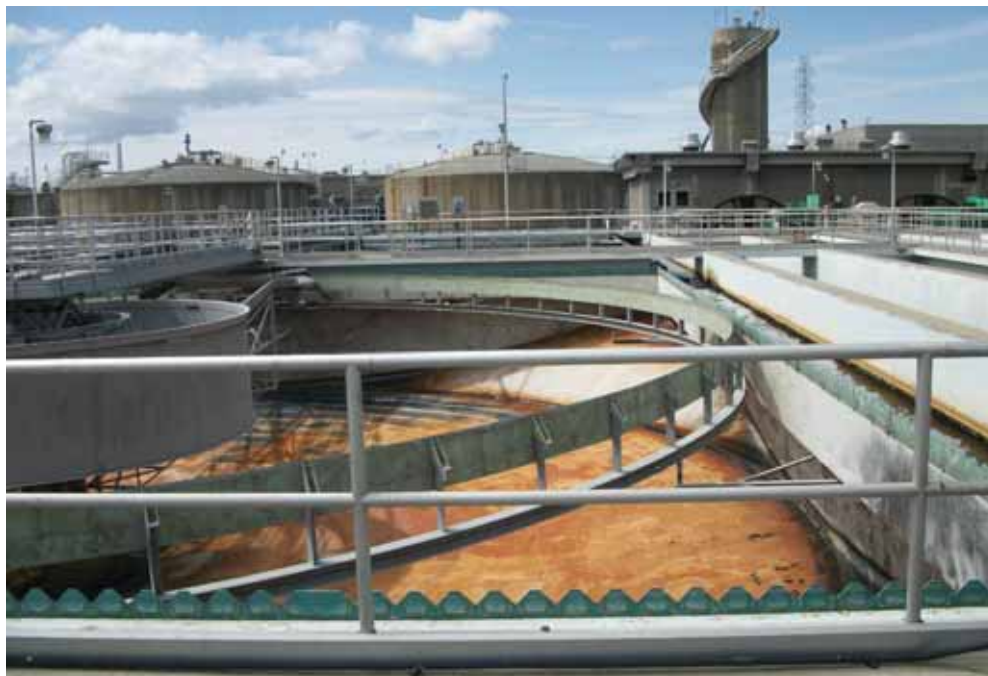
The Secondary Clarifiers 1-4 are a group of four open-air tanks formed by robust cast-in-place, below grade concrete walls. The clarifiers were constructed during the 1978 phase of construction at the site, and sit adjacent to the Chlorine Contact Tank, the Effluent Pump Station, Sludge Pump Room #2 and Control Box #3. The main potential life-safety deficiency, as discussed below, does not relate to the clarifiers but rather to the adjacent structures. The Secondary Clarifiers 1-4 are shown in Figure 40. Note that one of the 4 cells is usually empty at any given time.

Figure 40: Secondary Clarifier 1-4, Empty Cell

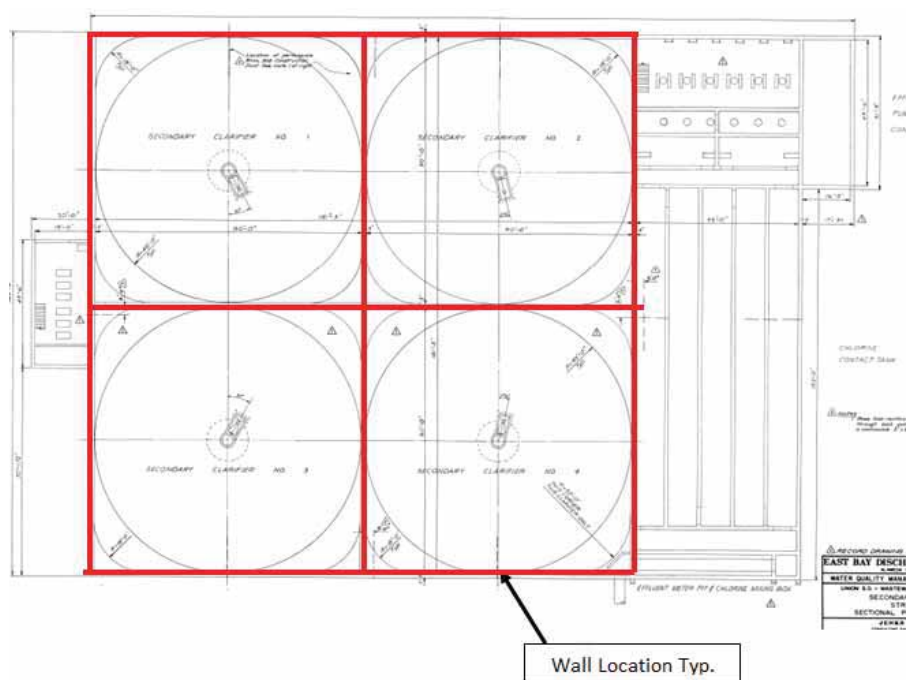
The walls of the Secondary Clarifiers 1-4 have been preliminarily analyzed for the incremental fluid and inertial forces from the DBE. The thick and well reinforced walls are sufficient to resist the incremental pressure based on preliminary analysis. The concrete wall locations of Secondary Clarifiers 1-4 are shown in Figure 41.

Figure 41: Secondary Clarifiers 1-4 Concrete Wall Locations

The Secondary Clarifiers 1-4 are physically connected to EBDA pump station and Chlorine Contact Tank. With more advanced analysis this is likely not a deficiency, as all 5 structures are stiff structures.

The roofs of Sludge Pump Room #2 and Control Box #3 are precast concrete roofs which are almost certainly deficient. They represent collapse hazards that could fall off their walls and onto the Secondary Clarifiers.

The EBDA pump station roof is a precast roof which as originally constructed was very likely deficient and had the possibility of collapsing and damaging the clarifiers. This roof has been retrofitted after the original construction so this risk has likely been mitigated. However, specific study of the EBDA pump station and the retrofit work is beyond the scope of this report, and further study is necessary to confirm this potential hazard.

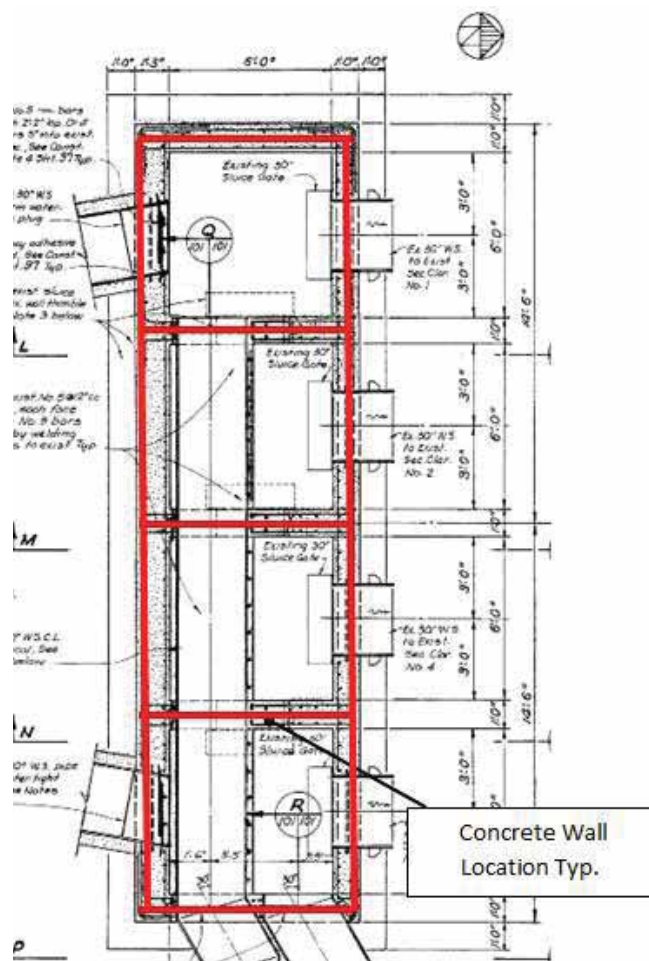
Figure 42: Control Box #3 Wall Locations

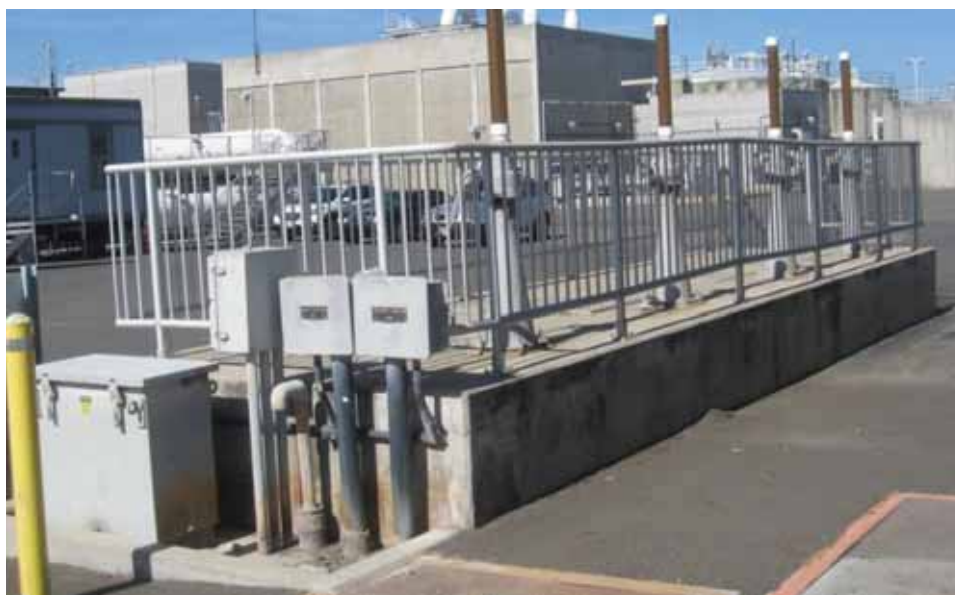
Figure 43: Exterior View of Control Box #3

The concrete walls are thick and well reinforced. The horizontal span between walls is small which helps span the soil and fluid pressures to the cross walls. Given the robustness of the construction, Control Box #3 is expected to perform well in a seismic event. The ASCE 41-13 identified potential deficiencies are relatively minor, and are discussed in greater detail below.

Note that our analysis of Control Box #3 assumed that the structure was in good condition. We were not able to access the condition of the below grade walls because they are obscured by fluid. From grade level, the concrete walls appeared to be in good condition, but we recommend that a condition assessment be completed as a follow-up to this study.

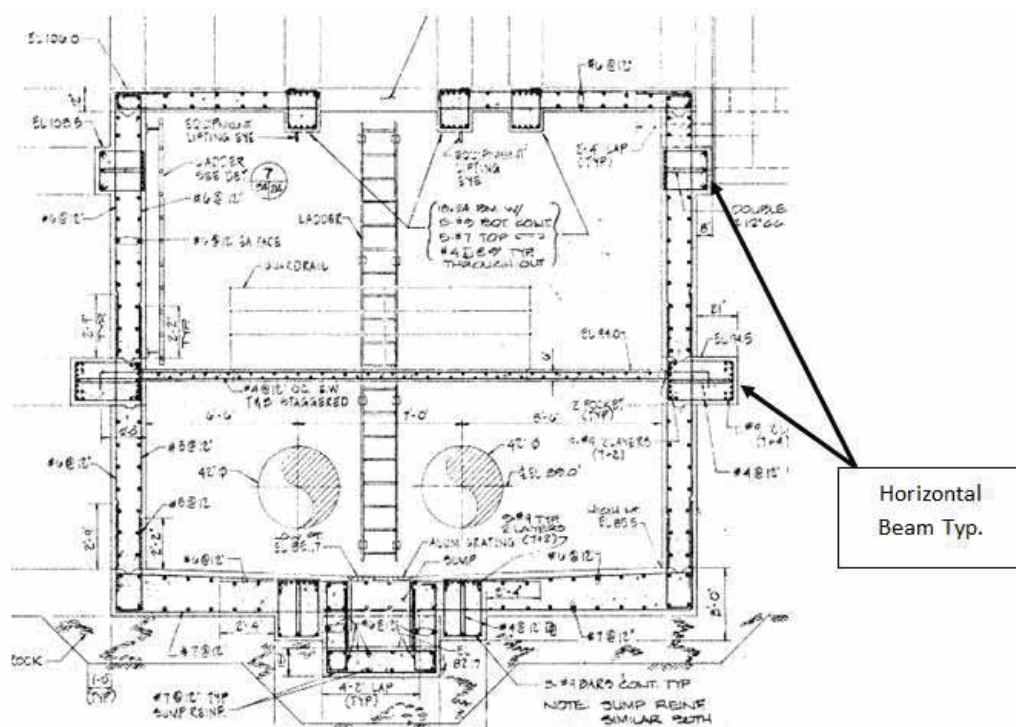
Note that our analysis of the Alvarado Vault assumed that the structure was in good condition. We were not able to access the inside of the vault because of safety concerns and therefore do not know what structural condition the vault is in. From grade level, the concrete walls appeared to be in good condition, but we recommend that a condition assessment be completed as a follow-up to this study.

Figure 44: Alvarado Influent Valve Vault Elevation

A small vent structure is located 1" away from the vault near the ground surface. While this is not of particular concern for the larger vault structure, the seismic surcharge load from the vault on the vent structure may affect and damage the vent structure. This should be studied in greater detail.

The access openings at the ground level are slightly greater than 25% of the wall length. This deficiency is very not likely a life-safety concern with additional analysis.

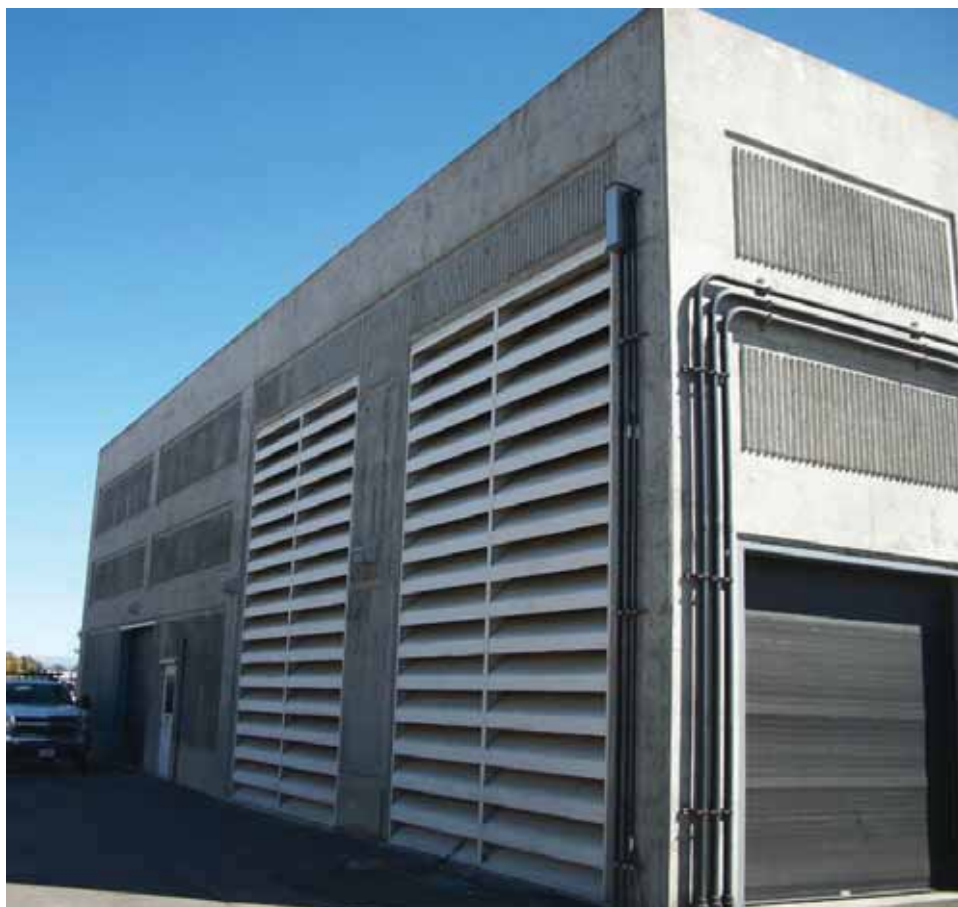
The Main Electrical Distribution Building is a single high-bay cast-in-place concrete shear wall building with a lightweight steel framed roof structure. The structure was constructed in the early 1990's and is shown in Figure 45. Typically buildings like Main Electrical Distribution have sufficient walls to resist seismic forces, but have deficient wall-to-roof anchorage for out-of-plane wall forces. See Figure 46, which highlights the locations of the concrete walls. This is particularly true of high-bay wall structures, where wall-to-roof anchors must resist the forces from a tall section of wall. The Main Electrical Distribution Building, however, is robustly tied into the steel roof members, which are capable of developing the out-of-plane wall forces into the diaphragm. During the analysis of this structure, no structural deficiencies were identified that pose a significant life-safety concern.

Figure 45: Exterior View of Main Electrical Distribution Building

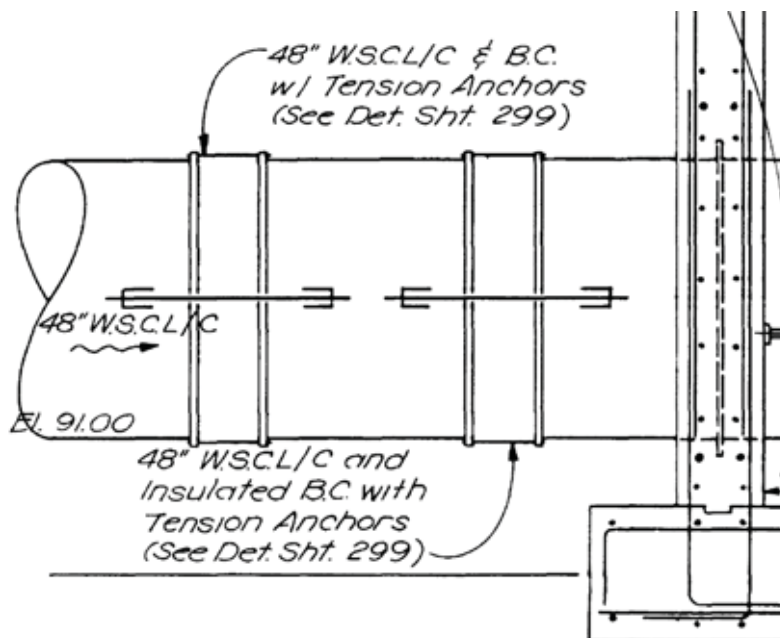
Based on data provided by the District, we understand that the gravity liquid flow train piping is all welded steel pipe. In review of the drawings for the original 1978 plant construction, and expansions in 1985 and 1992, double flex joints with bolt harnesses are shown at the interface between structures and buried pipe (See Figure 47). This typical design allows rotation in two locations so as to accommodate differential settlement. The combination of welded steel pipe with double flexible joints should accommodate expected differential settlement without causing pipe failure. While double flexible joints were identified on selected gravity flow train piping, all pipe-structure interfaces were not reviewed, so there is potential that some pipelines do not have the double flexible joints.

Figure 47: Typical double flexible joint with bolt harnesses. Detail on Meter Pit No. 4.

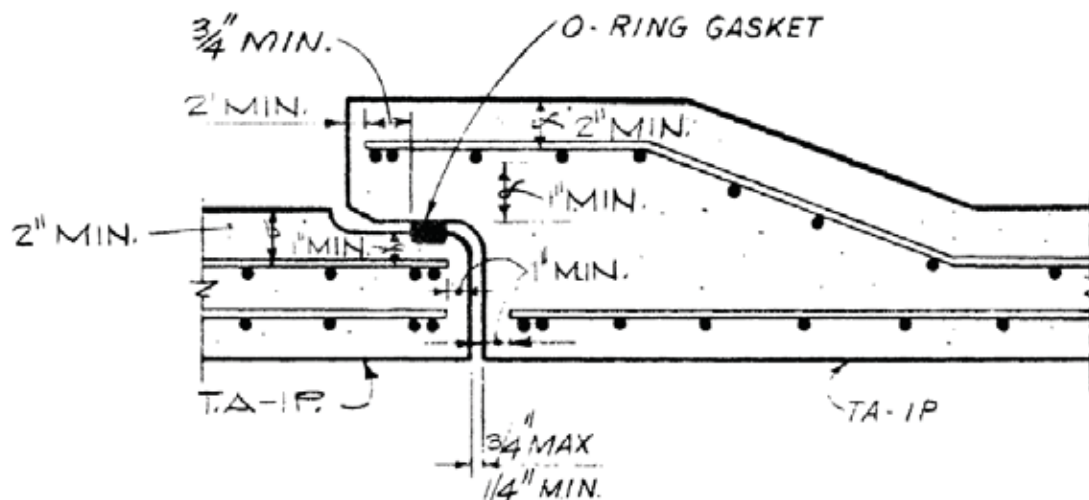
The force mains, built in the late 1970s, are constructed with 12-foot segments of reinforced concrete pipe with bell and spigot gasketed joints (Figure 49). This joint should allow extension on the order of 1-inch before it starts to leak. The joint detail shows a gap of $\frac{1}{4}$ -inch to $\frac{3}{4}$ -inch between the end of the spigot end of the pipe, and the back of the bell. It is likely that this gap has filled in with debris, so limited compression capability is expected across the joint. Special joint designs are used where required for special situations. In some cases, these special joints may be welded, not allowing movement between the pipe segments. Flexible couples are used in locations where differential movement was expected by the designer.

Figure 49: Typical reinforced concrete pipe bell and spigot gasketed joint

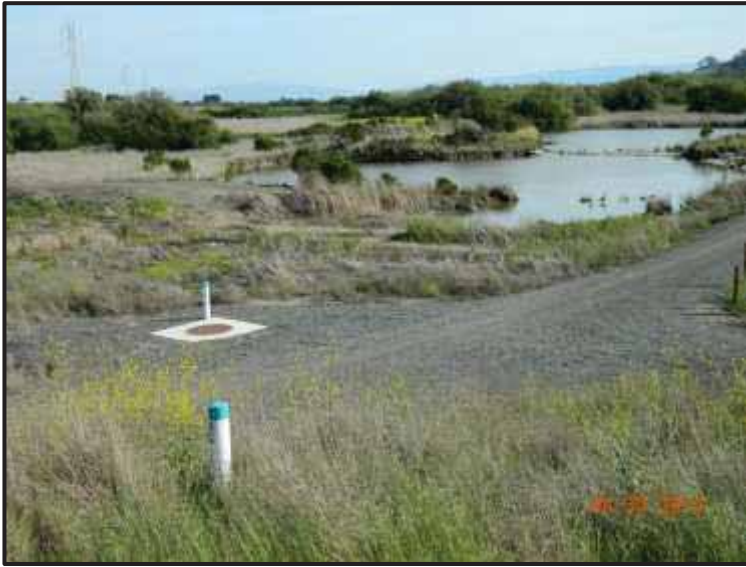
The twin force mains cross under Alameda Creek and are immediately adjacent to ponds on the south side of Alameda Creek. At this location, the soils consist predominantly of Alluvial Fan and Fluvial Deposits (see Figure 1). As previously discussed, the interlayered silty sands and sands within these deposits are subject to liquefaction. The channel area is approximately 910 feet wide (between two force mains manhole structures). The channel itself is about 750 feet wide (including levees), about 20 feet deep below the top of levees and about 10 feet deep below adjacent local ground surfaces. The depth of cover within the channel and specifically at the low flow channel is only a few feet and as such lateral spreading upon liquefaction of the shallow interlayered alluvial sands is a risk warranting further investigation. The pond area immediately south of Alameda Creek is immediately adjacent to the force mains alignment with the bottom of the ponds at elevations lower than the nearby force mains (see original force main drawing no. 9 and pipeline station 112+00 to 116+00). The ponds immediately adjacent to the force mains extend over a length of approximately 940 feet south of Alameda Creek. The Alameda Creek undercrossing and the ponds south of the creek represents the principal location along the 13-mile twin force main alignment where large-scale ground deformations from lateral spreading directly impacting the force mains are a possibility. Further site-specific investigation is warranted at this location to establish the:

Photo 3 – Southward view of ponds on the south side of Alameda Creek and the force mains alignment indicated by 3 marker posts.

- a) design and as-built construction details for the twin force mains creek undercrossing (e.g. concrete encasement, concrete cap, pipe anchorage, etc.),
- b) likelihood of liquefaction and lateral spreading into the creek,
- c) stability of the creek bottom and levees upon liquefaction,
- d) stability of the pond bottoms and slopes upon liquefaction, and
- e) lateral extent of spreading north and south of the creek.

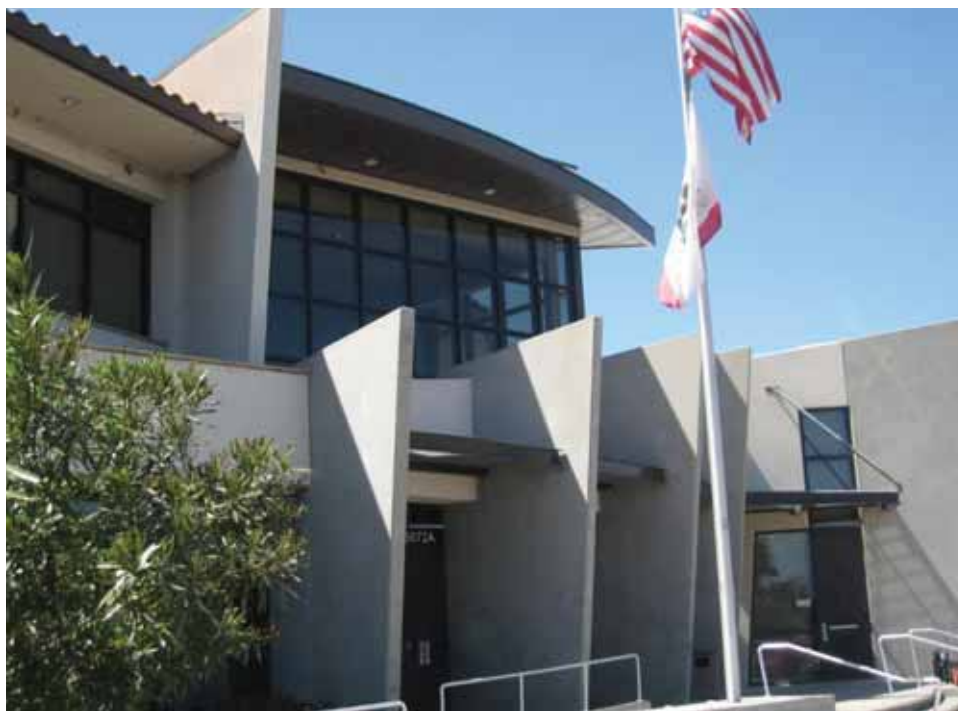
There are numerous and very serious deficiencies in the lateral load path at the roof level.

- ☐ ☒ ☐ ☐ ADJACENT BUILDINGS: The clear distance between the building being evaluated and any adjacent building is greater than 4 percent of the height of the shorter building. This statement shall not apply to the following building types: W1, W1A, and W2. (Commentary: Sec. A.2.1.2. Tier 2: Sec. 5.4.1.2)

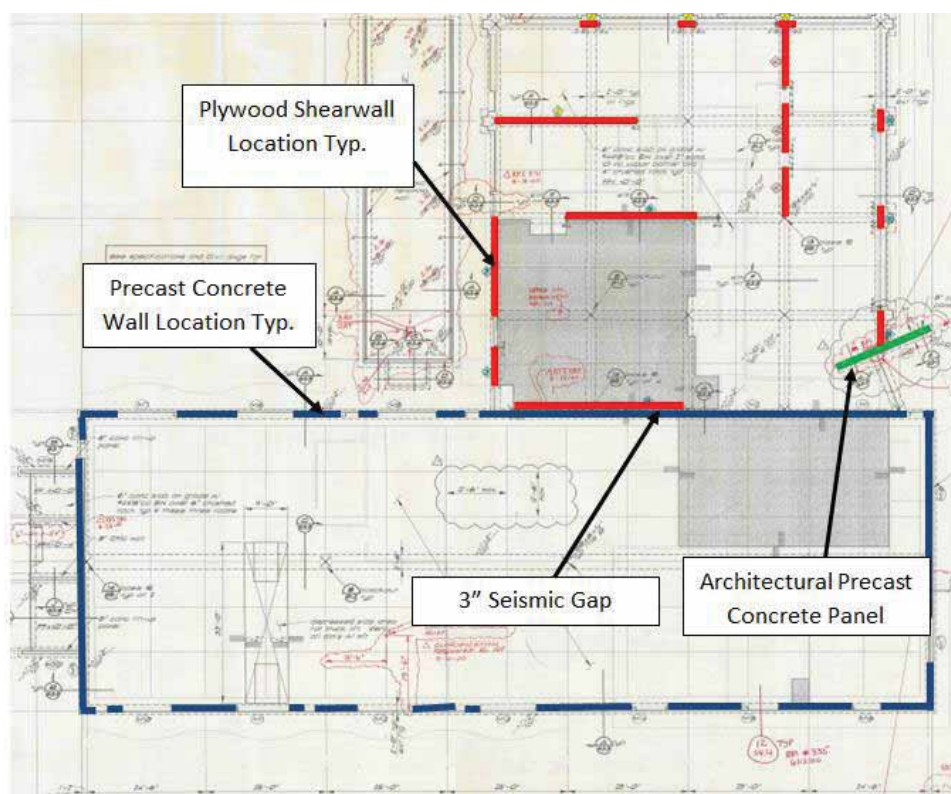
The locations of the plywood shear walls and precast concrete tilt-up walls are shown in Figure 7. As noted in greater detail below, the main deficiency of the Field Operations Building is the deficient connections between the precast concrete walls and the plywood diaphragms. These limited connections are not expected to perform well in the DBE. Furthermore, the structural separation between the two structures is inadequate based on Tier-3 analysis procedures which could lead to pounding between the two structures. Retrofit strategies to address these deficiencies are discussed in greater detail below

Figure 7: Wall Locations in Field Operations Building

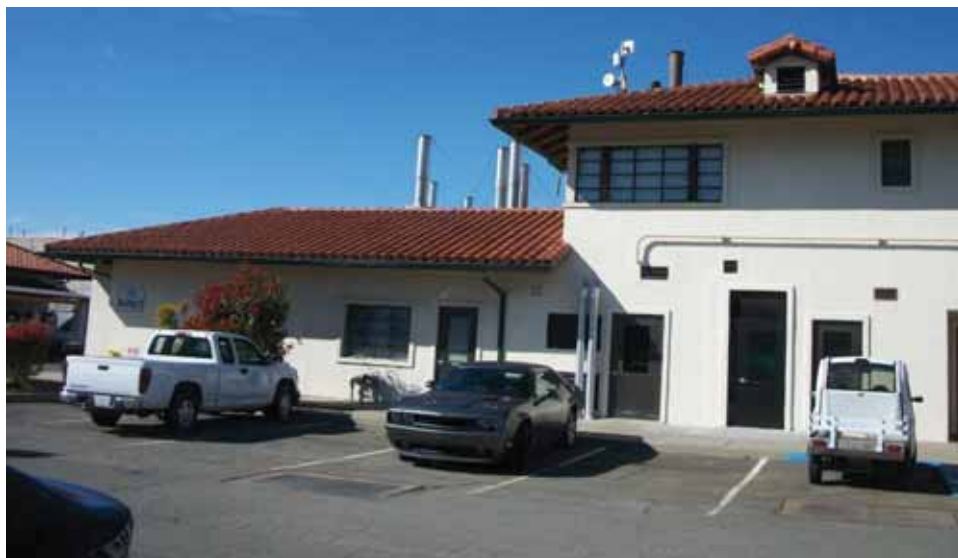
The Control Building is a light cold-form steel framed partial two story structure. The structure has a complex pitched, Spanish Clay Tile clad roof. An exterior view of the Control Building is shown in Figure 8. This Spanish Clay Tile roof is heavy and adds a significant amount of seismic mass to the otherwise light structure.

Figure 8: Exterior View of Control Building

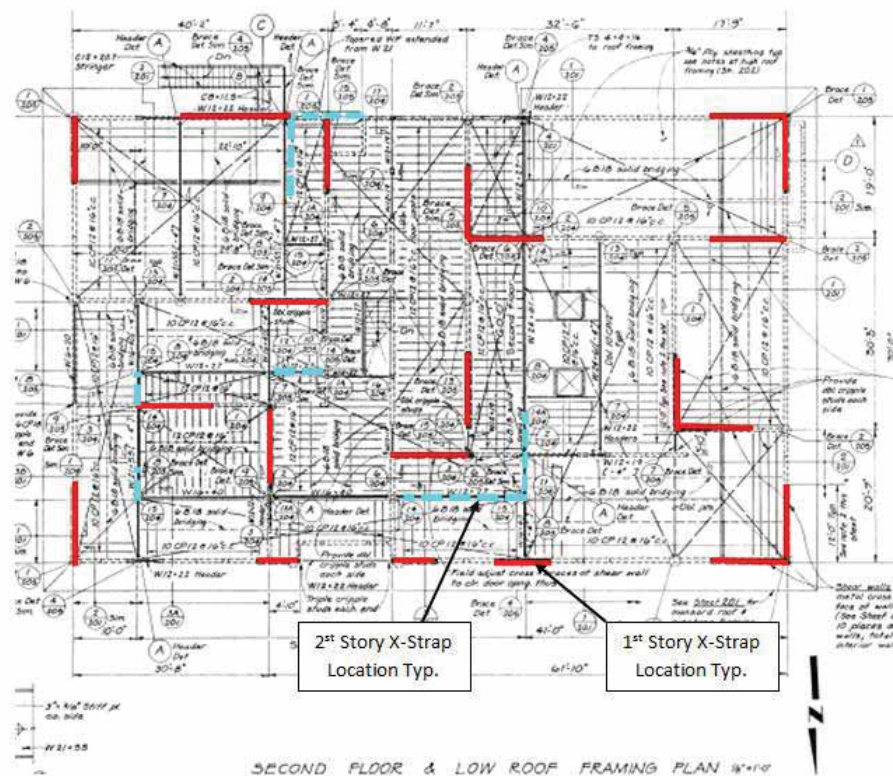
The building was constructed during the 1978 phase of construction, and has $\frac{3}{4}$ " plywood diaphragms with gauge metal straps at discrete locations. Sheet metal X-bracing straps were originally designed to serve as the Control Building's seismic force resisting system. The locations of the sheet metal X-bracing straps are shown in Figure 9. Note how the bracing locations do not align between the two floors.

Figure 9: Control Building X-Strap Wall Locations

As noted below, these straps are much more flexible than the exterior stucco walls and interior gypsum board walls. Therefore, the strap walls will only be engaged after the other walls have sustained significant damage. In a seismic event, the plywood diaphragms will transfer the inertial load to the various walls in the Control Building, which will ultimately transfer the loads to the foundation. Typically, light-framed, low-rise structures like the Control Building perform well in seismic events. However, due to the many discontinuities in the lateral system, and because of its heavy roof, the Control Building will not perform as well in the design seismic event as other light-framed structures. These deficiencies and associated retrofit measures are discussed in greater detail below.

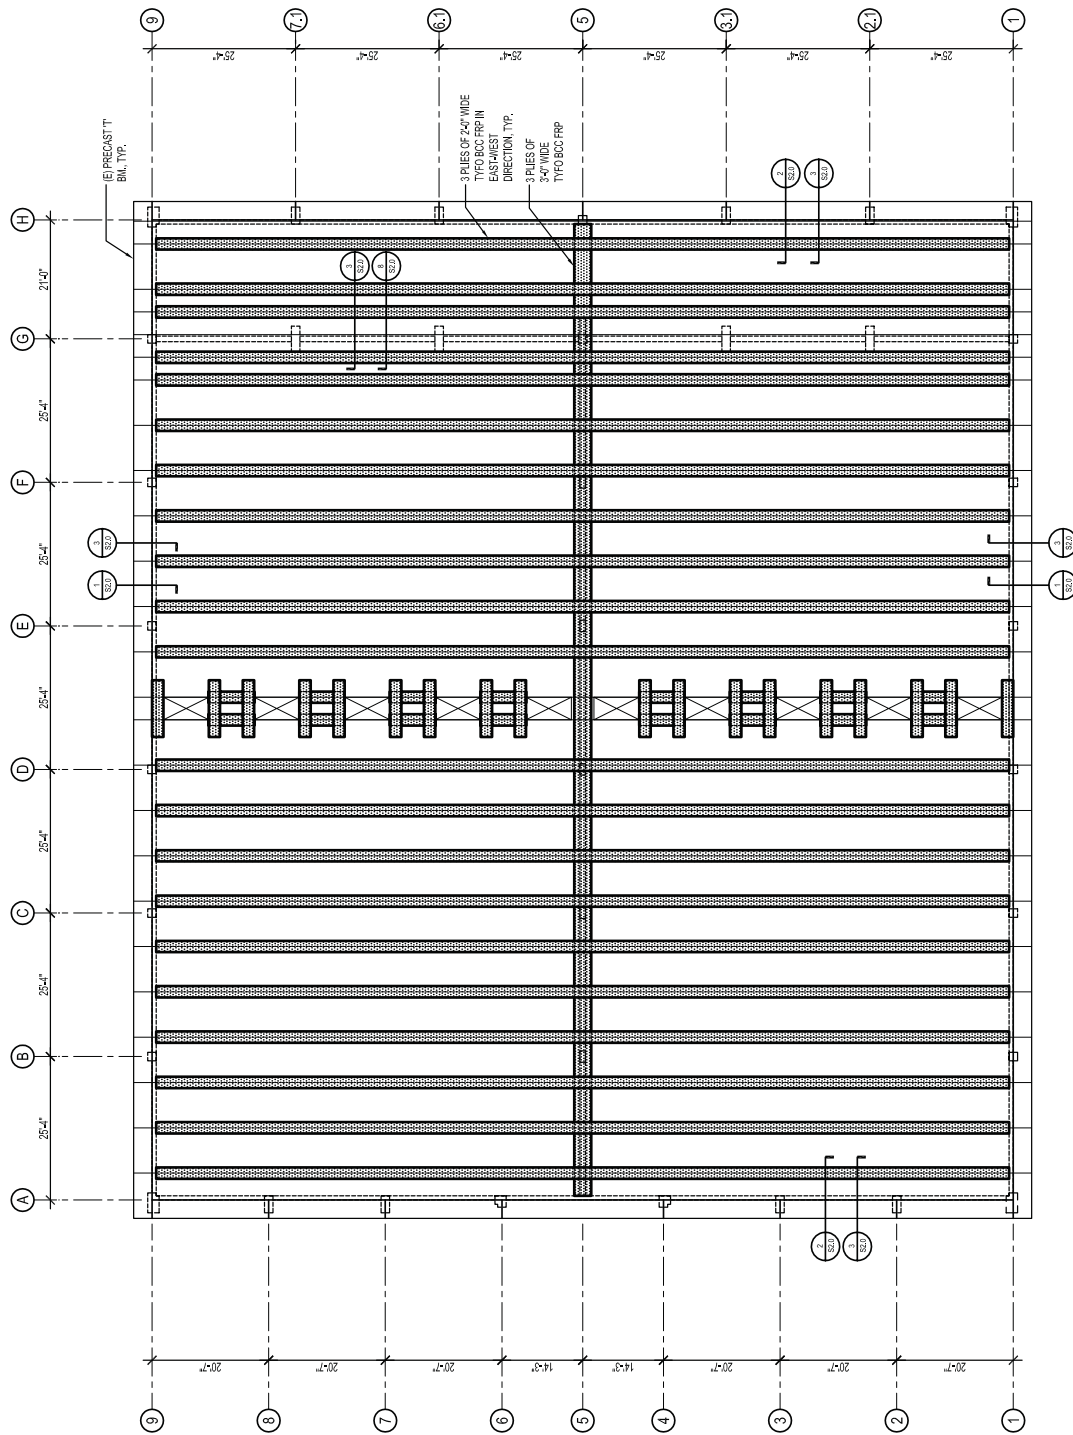
The diaphragm ties that connect the Precast Double Tee roof beams together are corroded and will be ineffective at keeping the diaphragm together in the DBE. Once the panels begin to break apart, the strength of the Double Tee roof beams will be significantly compromised and the precast double t-panels themselves could begin to break apart. To mitigate this deficiency, we propose strengthening the Precast Double Tee joint with Fiber-Reinforced Plastic (FRP) sheets. These FRP sheets can either be installed above or below the roof along the joints between the Double Tee beams. Installing the sheets from below would require scaffolding and would require sequencing in order to complete the work one quadrant at a time in the unfilled cells. Completing the work from above the concrete beams would require the removal and replacement of the existing roofing membrane but for the installation of the strips themselves it will be much more cost effective to install the FRP strips from above the roof. The diaphragm RFP strengthening is shown in Figure 1-1.

Figure 1-1: Primary Clarifier 1-4, Roof Plan
